# NEW DESIGN GUIDE

2020

This New Design Guide is a complete updating of the previous one. The REPAIRABILITY Working Group has removed the obsolete points and added new ones so that the new content is in line with the latest technologies.

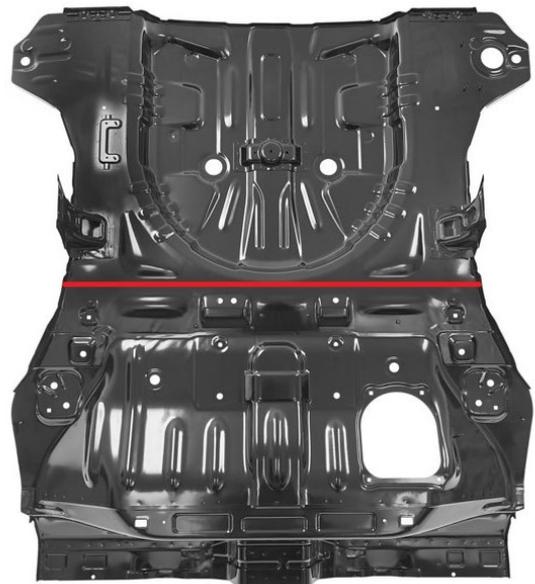
Poor Example

Large service condition—excessive intrusion

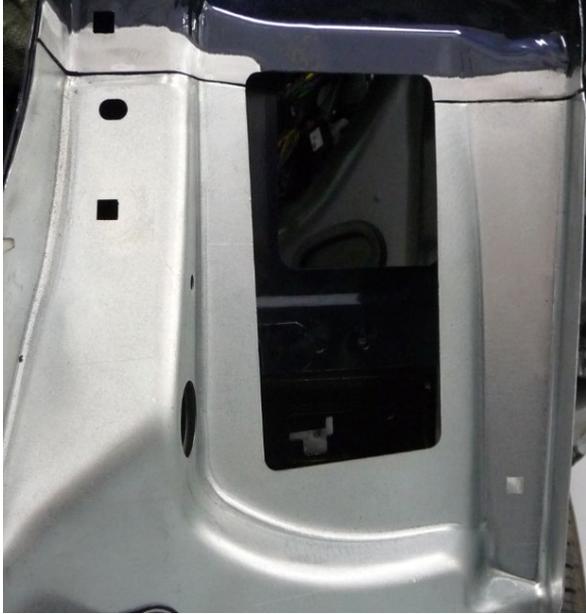
Good example

Lamp panel section (partial replacement) that removes the need to remove rear quarter panel.

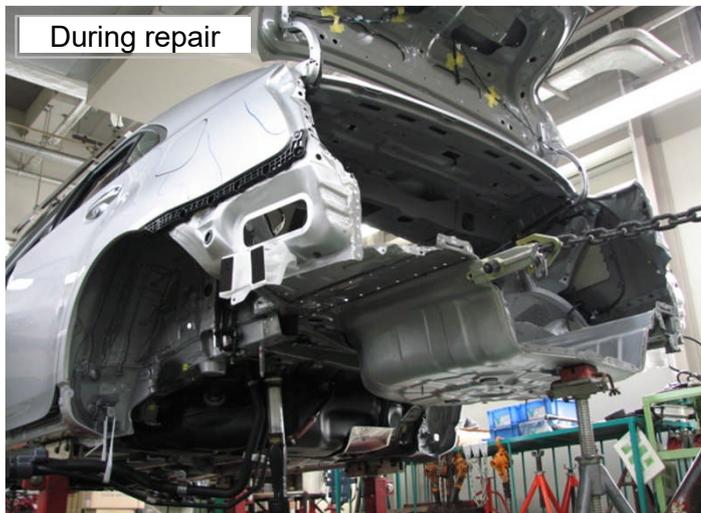
Good Example

The quarter panel and rear side member were damaged and needed to be repaired.

Removal of the fuel tank was not necessary as the fuel neck is separate from the fuel tank.

When the filler neck pipe and fuel tank are individual parts, removal and installation of the fuel tank is not necessary to repair the rear quarter panel, rear side member, etc., which reduces man-hours.

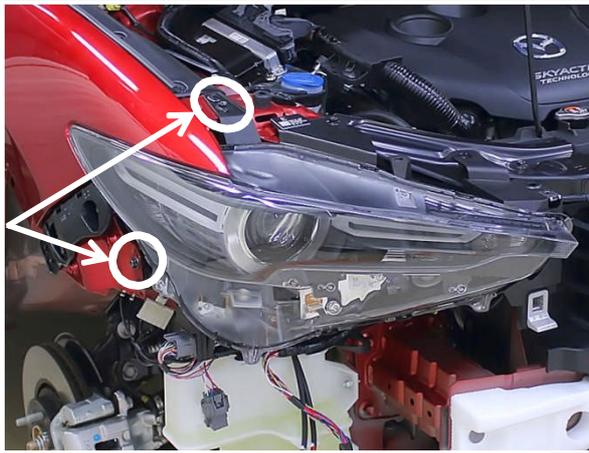
Example of a structure where the headlight is directly attached to the fender.

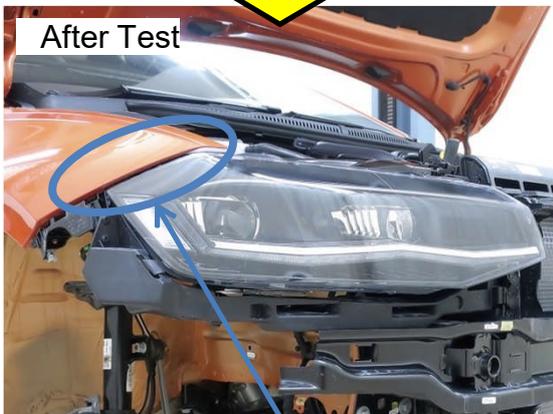
After Test

Fender was not damaged.

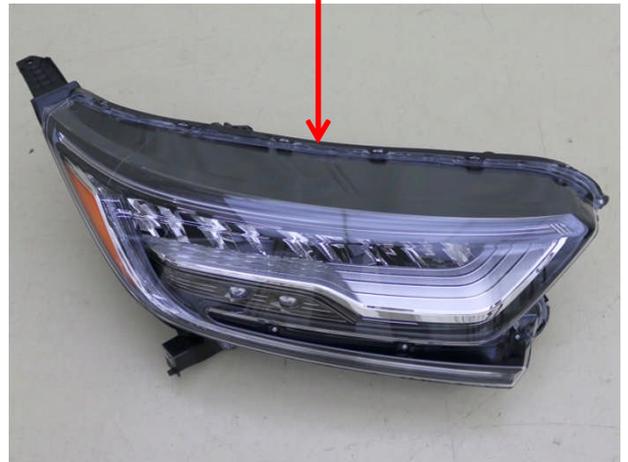
#### Poor Example

Parts are supplied as an assembly only.

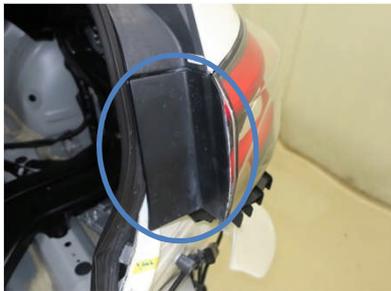
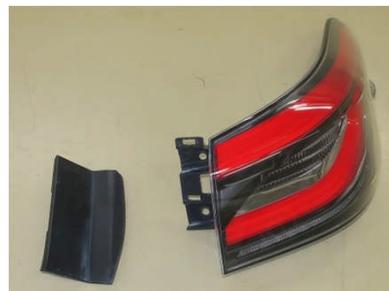
Example where there is a tail lamp garnish and the tail lamp garnish is supplied individually.

When there is a tail lamp garnish between the tailgate and the tail lamp and the tail lamp garnish is supplied individually, if the tail lamp garnish is damaged, it is not necessary to replace the tail lamp assembly or the unit, which reduces the repair cost.

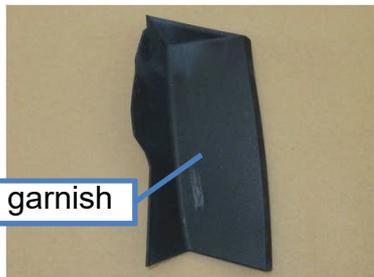
Tail lamp garnish

As the tail garnish was supplied individually, only the tail lamp garnish was replaced.

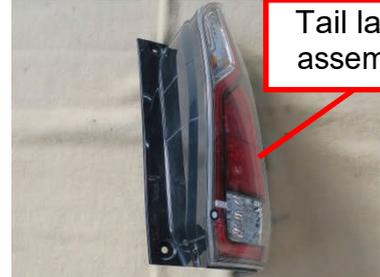
Tail lamp assembly

As the tail garnish was not supplied individually, the tail lamp assembly was replaced.

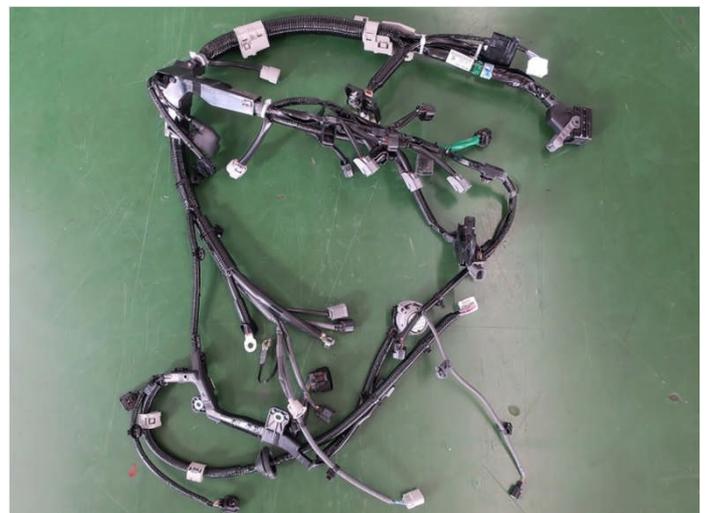
The main harness assembly had to be replaced as the auto brake controller connector was not supplied individually.

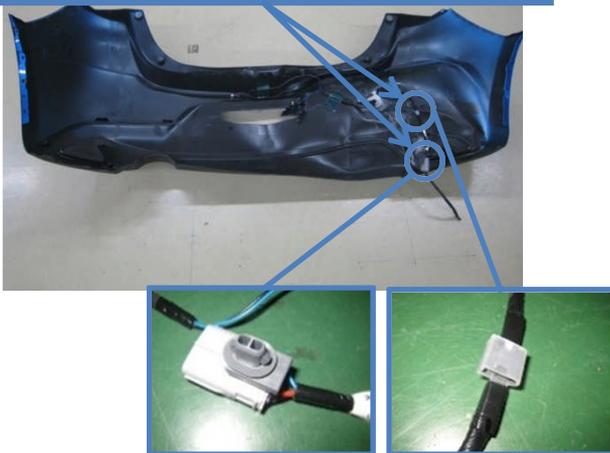
The harness clip and connector clip on the rear bumper cover were damaged.

Only the clips had to be replaced as the replacement harness clip and connector clips are supplied individually.

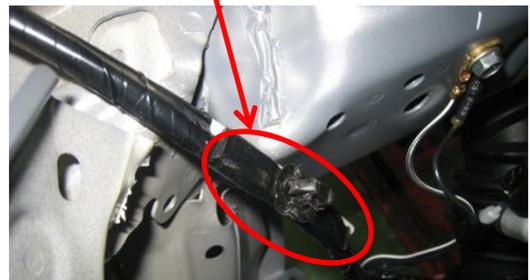
The harness clip on the side of the side member was damaged.

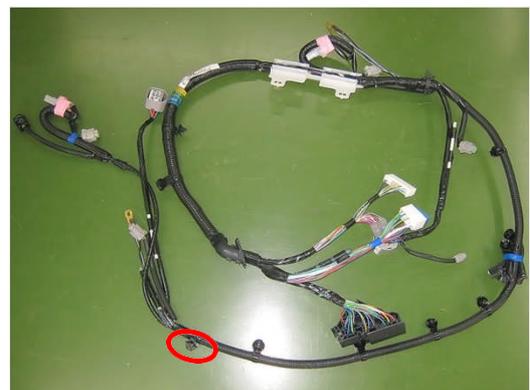
Only the harness clip was damaged, but the harness assembly had to be replaced as the harness clip is not supplied individually.

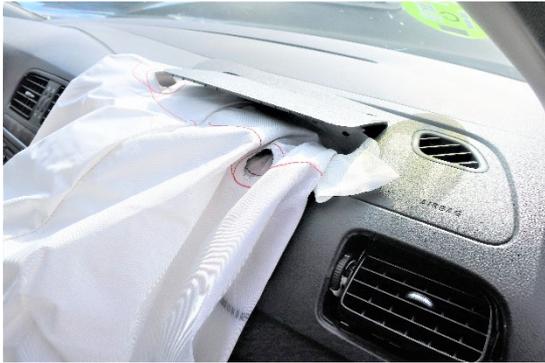
Good example

Deployment of airbag does not affect dashboard

The passenger airbag in its deployment should not break the cover of the dashboard to avoid an increment of the collision repair cost due to the replacement of this expensive part.

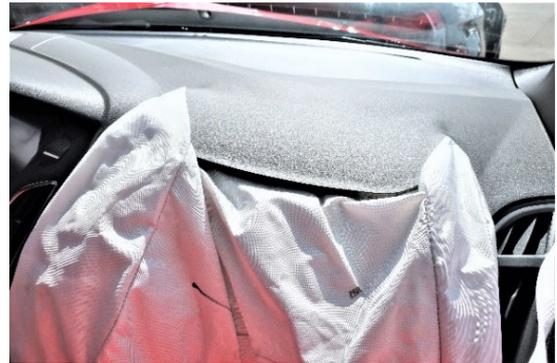
Poor Example

Deployment of airbag destroys dashboard

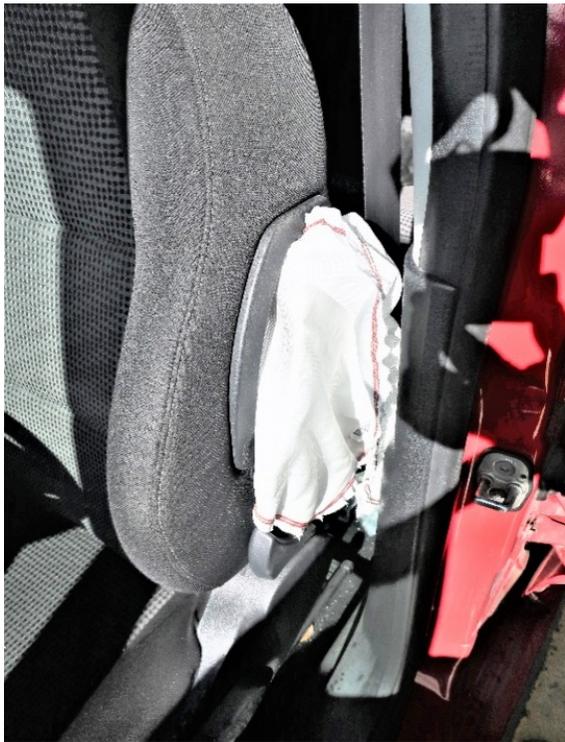
#### Good example

The side airbag module must be replaceable from the rest of the seat backrest.

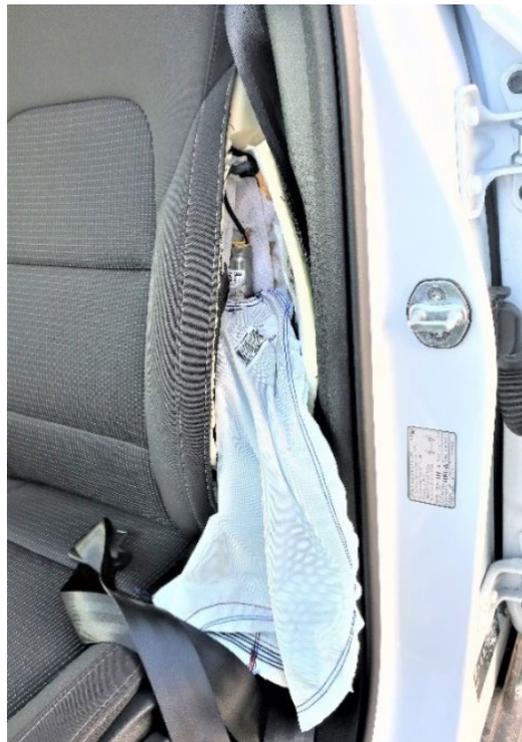
#### Poor Example

The lateral airbag breaks in its activation the padding and the upholstery of the backrest of the seat, this generates high repair costs

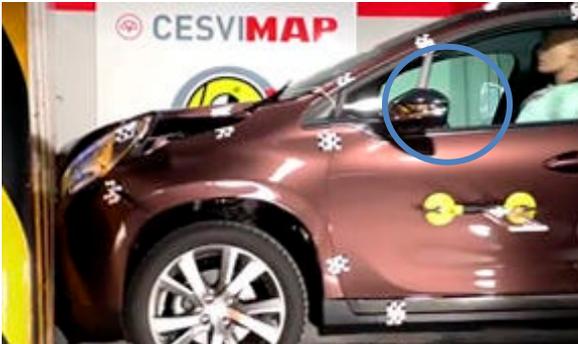
Good example

Airbag did not deploy at 15 km/h crash test

Deployment of airbags in low speed collisions increments unnecessarily repair costs and could cause personal injuries.

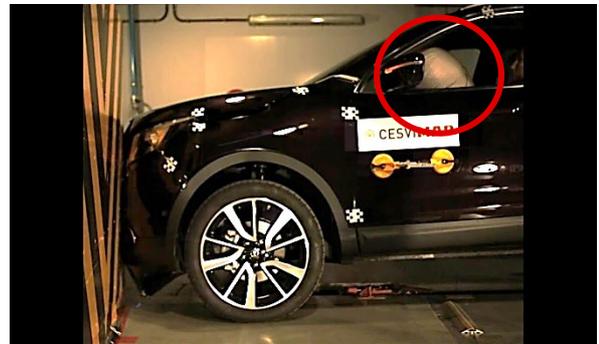
Poor example

Airbag deployed at 15 km/h crash test

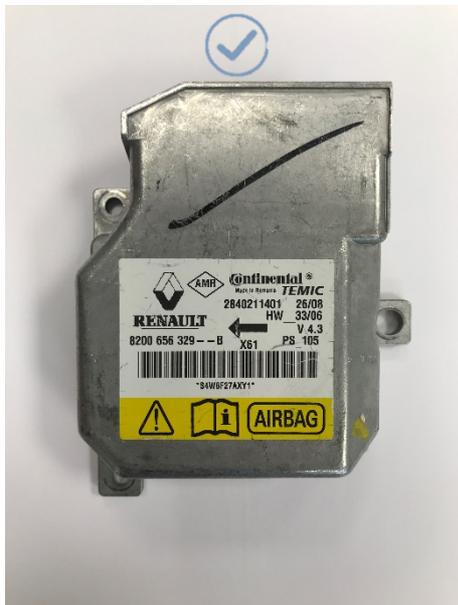
Good example

Reprogrammable airbag ECU

Reusing ECUs reduce repair costs.

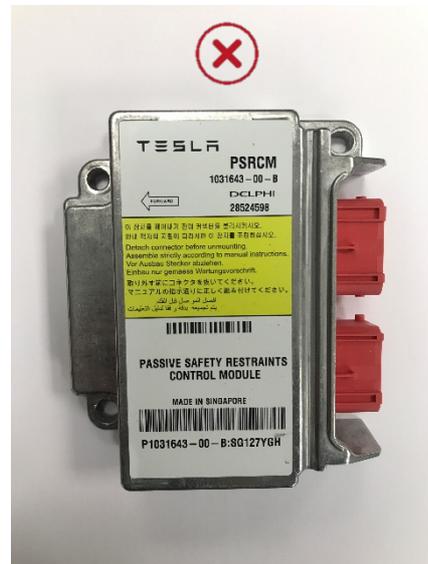
Poor example

Airbag ECU NOT Reprogrammable

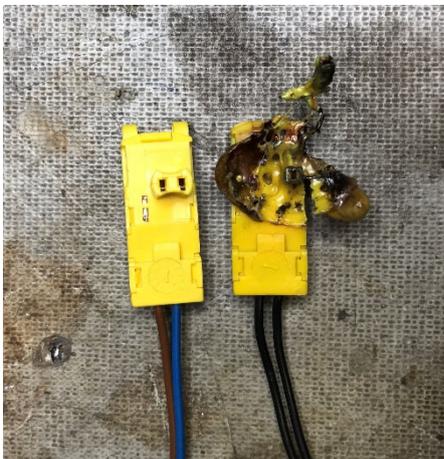
Good example

The airbag connector is supplied individually.

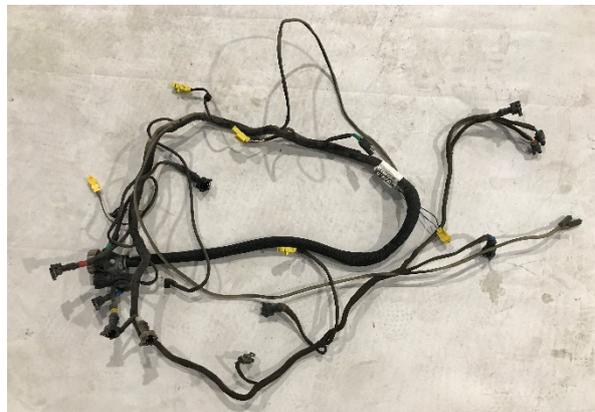
Poor example

To replace the airbag sensor connector, it is necessary to replace the main wire harness.

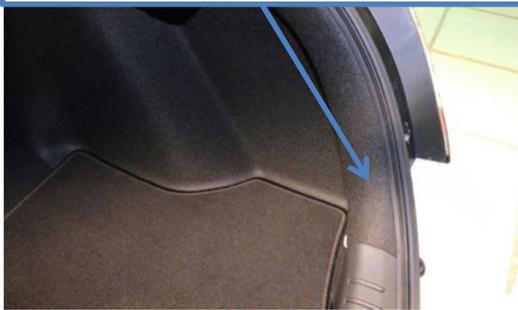
The quarter trim was not damaged because it is made with felt fabric.

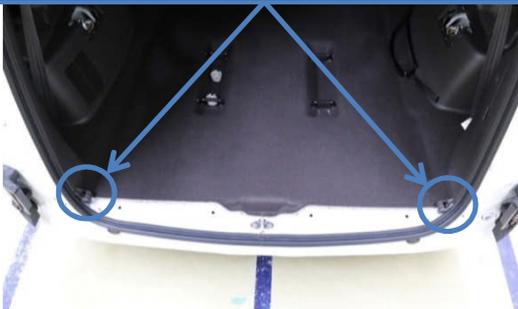
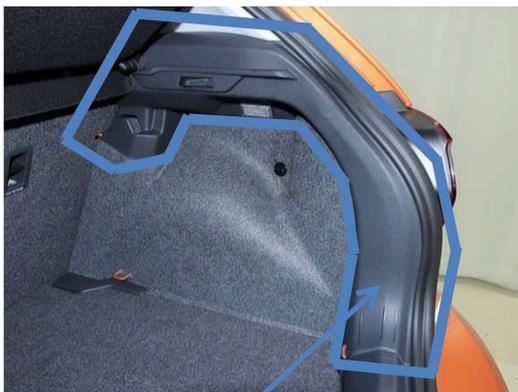
The quarter trim was not damaged because it does not extend to the tailgate opening.

Example where the quarter trim is not included in the assembly and is supplied individually.

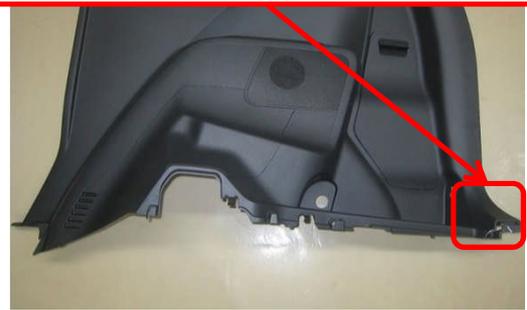
Only the end was damaged and turned white because the material used is not pliable.

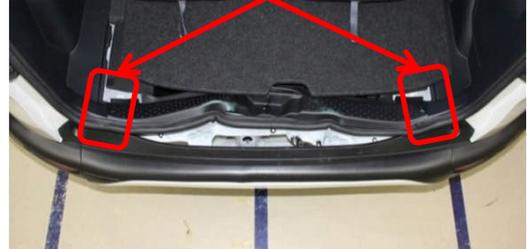
The quarter trim was damaged at the tailgate opening.

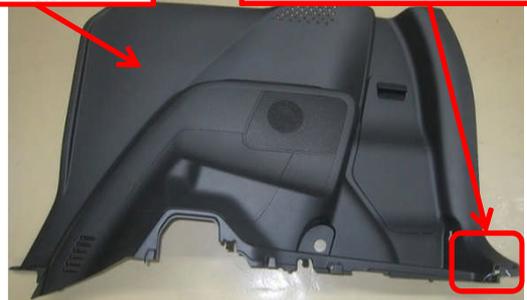
The quarter trim extends to the tailgate opening

No other areas were damaged.

Only around the opening was damaged.

The quarter trim was part of the integral structure, so the entire assembly was replaced.

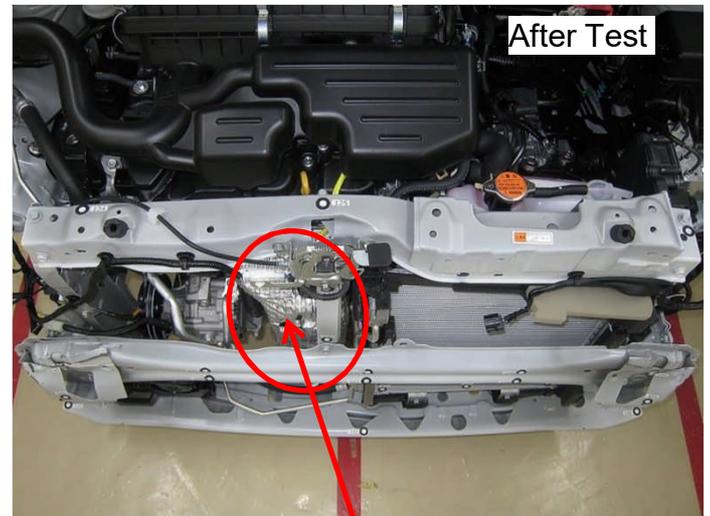
The exhaust manifold converter was pushed and damaged by the hood lock support.

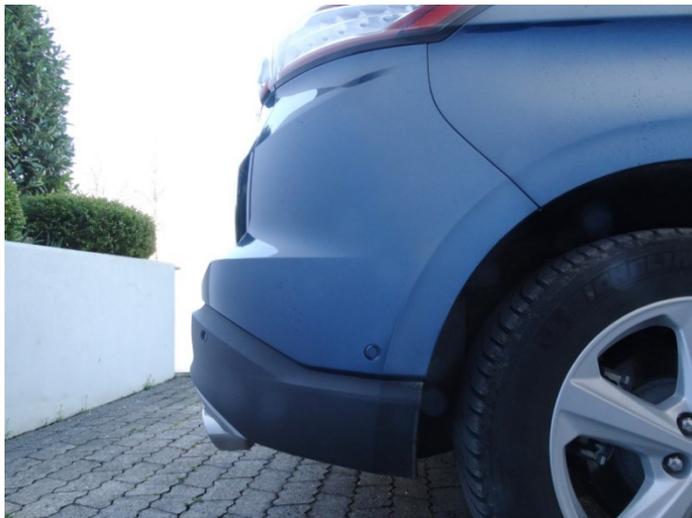
Two-piece rear bumper fascia spare part isn't delivered as two parts but heat-sealed and riveted which makes masking of the lower part (structured raw plastics) for painting the upper part very difficult.

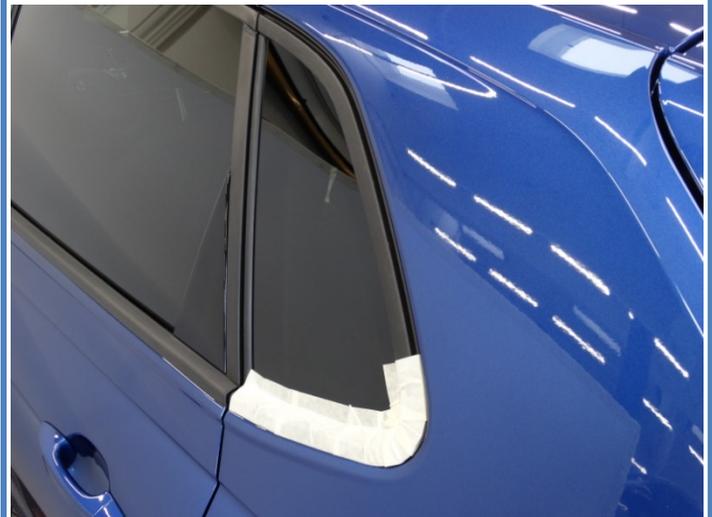
Glued-in side window with liftable seal - partially lifted with lifting tape.

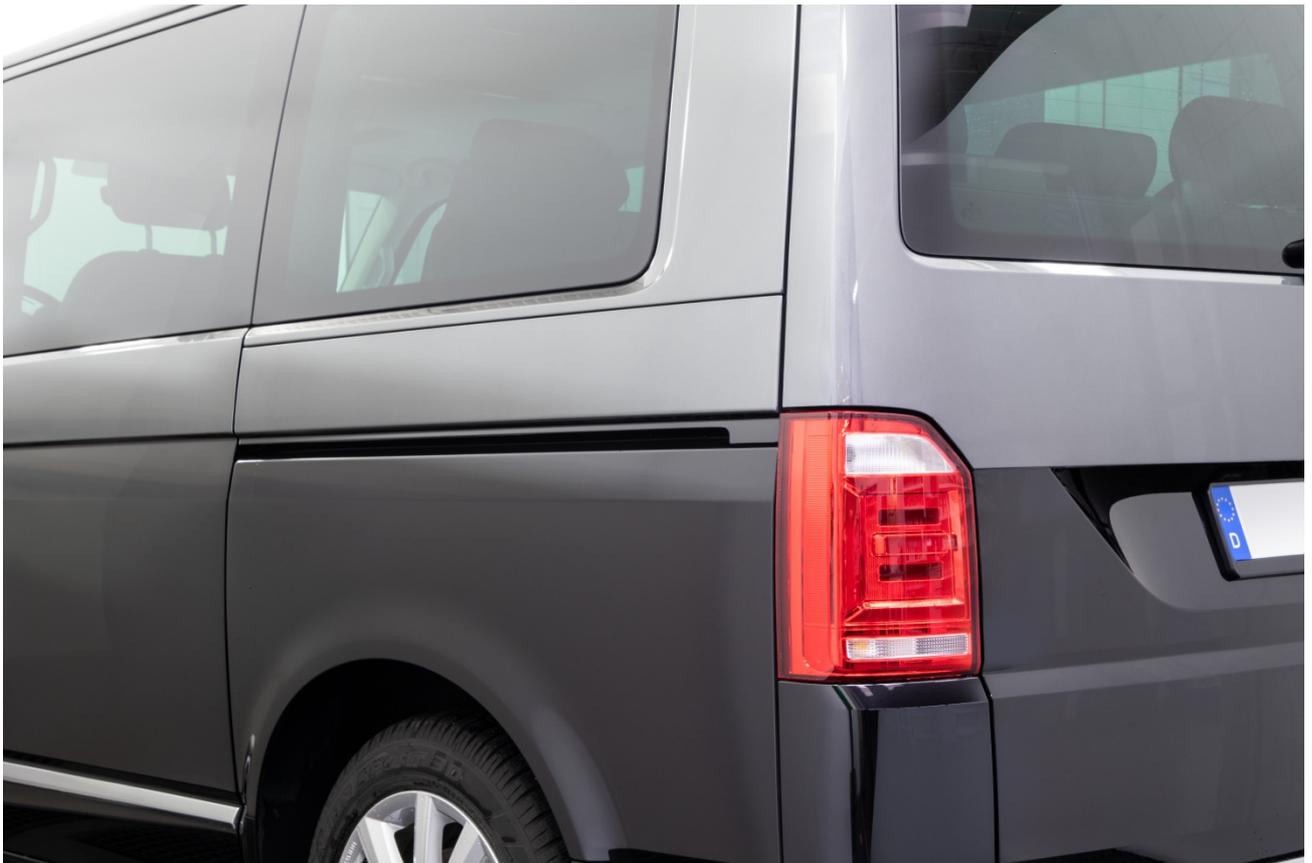
Vehicle with two-tone painting (twice metallic paint) on different parts leads to increasing efforts for masking and defining the appropriate colours to avoid blending.

Two or more colours on the same panel are difficult to blend in and will always show evidence of repair.

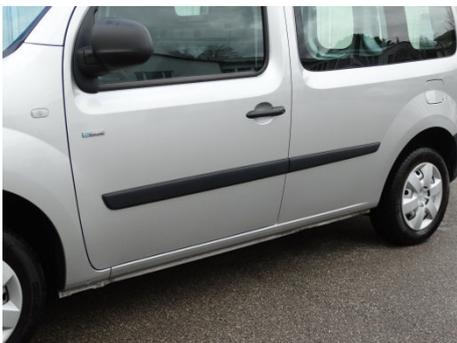
A protection strip that doesn't cover the whole width of the door panel does not allow painting of only a part of the door as zoning is not possible.

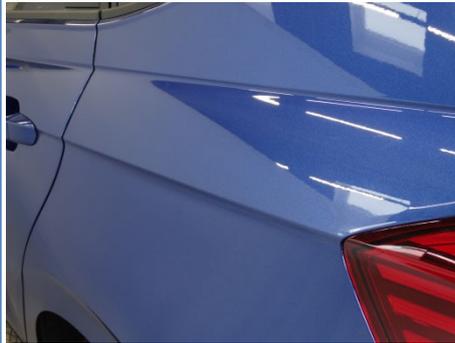
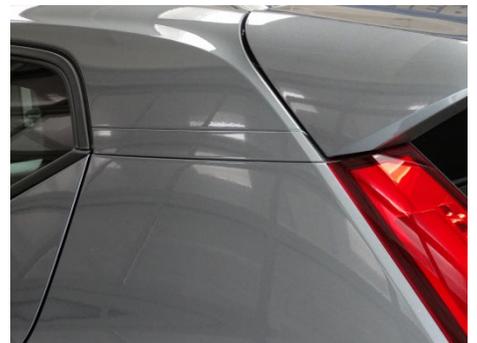
A continuous crimping / edge across the the whole side panel enables either the top or bottom of the side panel to be painted separately.

A plastic cover on the side panel which ranges from the rear side window to the tail-lamp divides the side panel in two parts that can be painted separately.

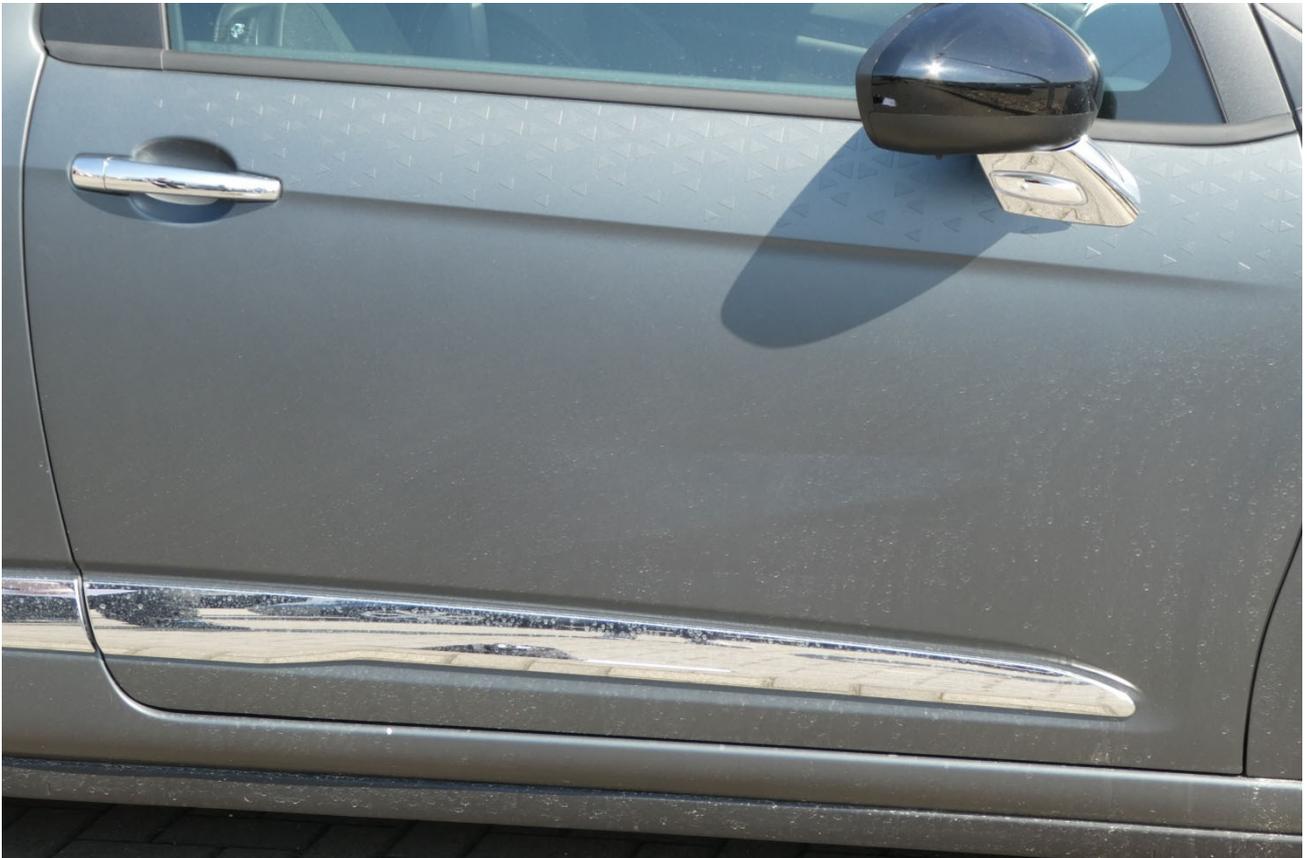
Foiled trim stickers and ornaments that are covered with clear coat together with the whole panel reduce the possibilities of repairing the damaged panel which results in additional costs.

Poor example:

Foiled ornaments on the base coat with additional matt clear coat on a door panel makes it necessary to paint the whole side of the car in case of a repair.

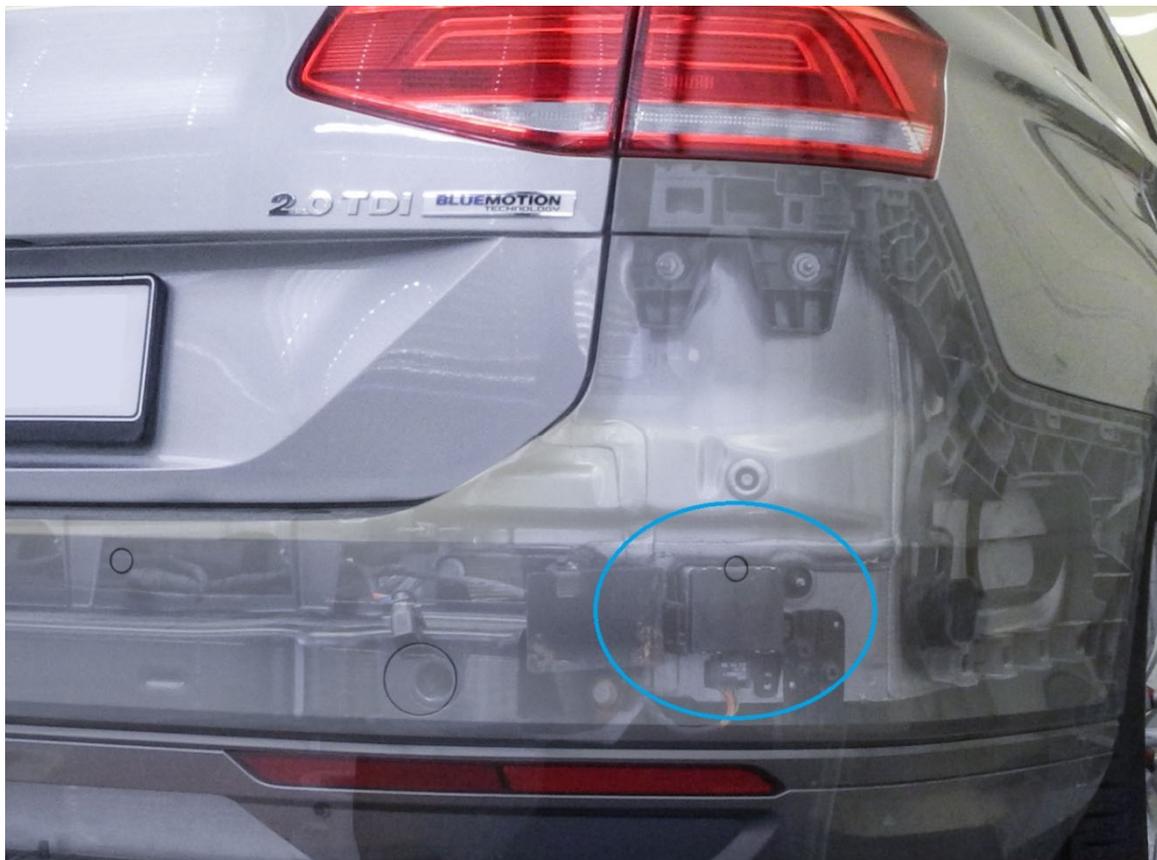
In case of a repair being necessary, this requires specific paint application with limited thickness and includes the prohibition of any repair methodology. Thereby additional costs occur as new spare parts are needed even for damages that would be repairable if there wouldn't be an ADAS sensor behind. Moreover paint thickness cannot be measured non-destructive on three-dimensional bended plastic parts reliable which may result in extra costs if the final calibration of an ADAS sensor failed at the end of the repair.

Poor example:

A rear radar sensor (blue marking) mounted underneath the rear bumper fascia (photo with semipermeable overlay).

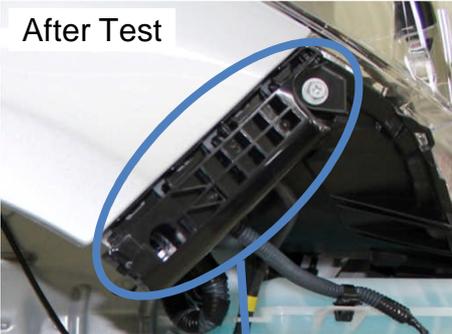
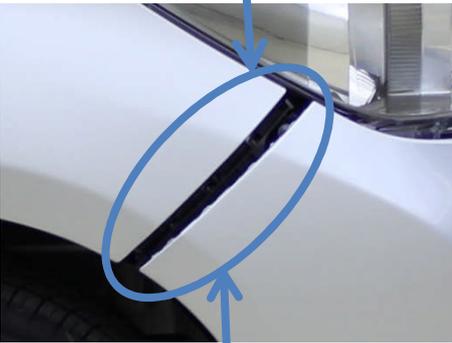
After Test

### Good Example

The fender and bumper cover are just fitted together and can be easily detached, which prevented damage to the rear fender.

When the front bumper cover (including radiator grille) mount is easily detached, damage is less likely to spread to the headlight, fender, and other expensive peripheral components.

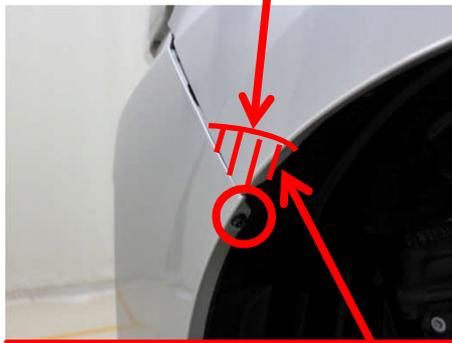
After Test

### Poor Example

The ends are fastened with screws, so the fender would also be damaged.

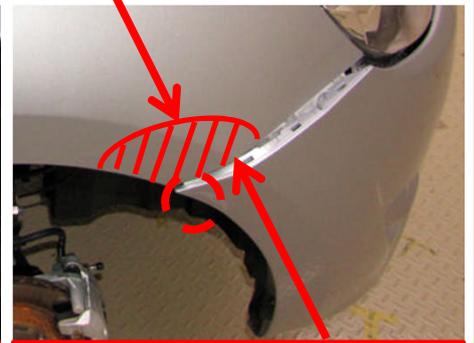
After Test

The ends are fastened with clips, so the fender would also be damaged.

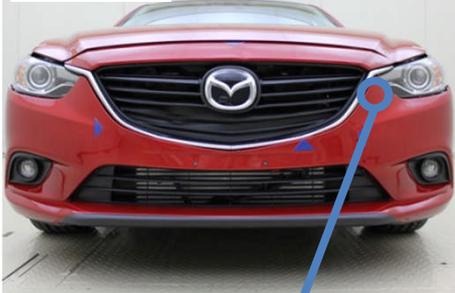
After Test

## Good Example

The grille bracket would be sheared off, which helps prevent damage to the headlight.

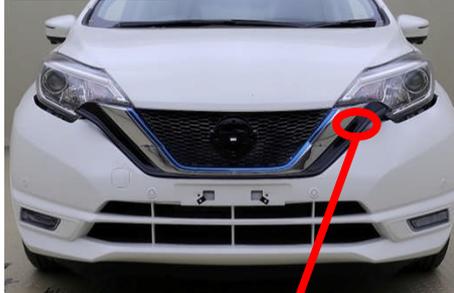
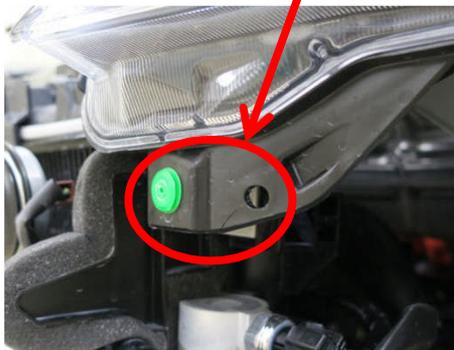
After Test

## Poor Example

The bumper cover and grille are attached to the headlight. Damage to the headlight is likely to occur.

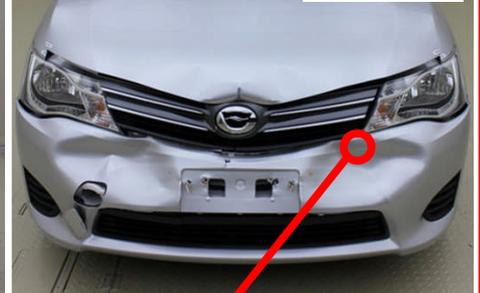
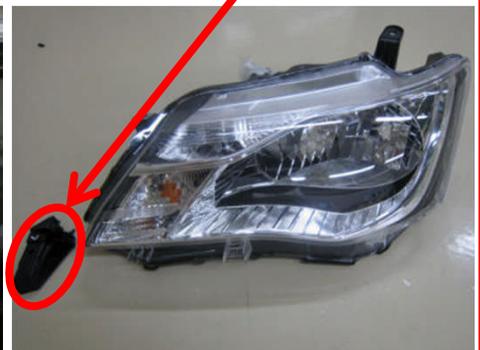
After Test

The bumper cover is attached to the headlight. Damage to the headlight is likely to occur.

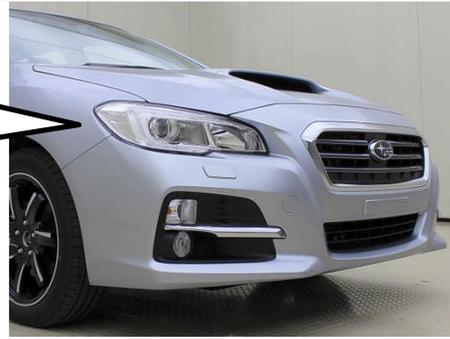
The headlight corner bracket is attached to the front wheel apron, upper bracket, etc.

○ Headlight corner bracket mount

Example of a structure where the bumper cover is not directly attached to the headlight but attached to the headlight corner bracket, which helps prevent damage to the headlight.

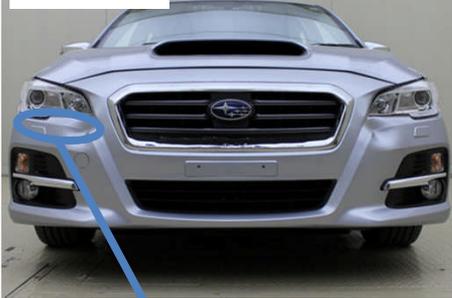
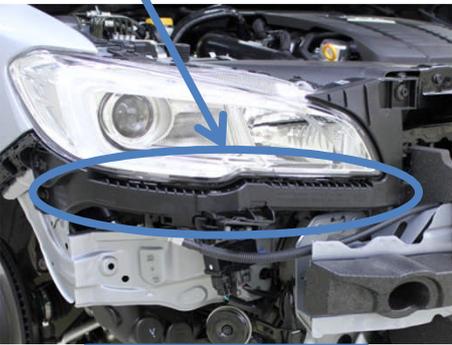
After Test

## Good Example

Headlight is not damaged.

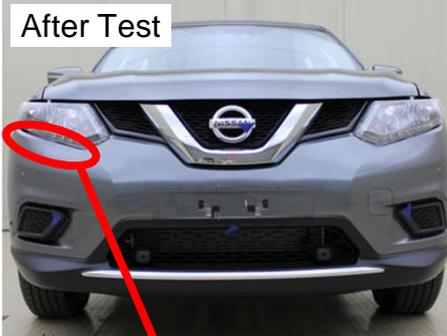
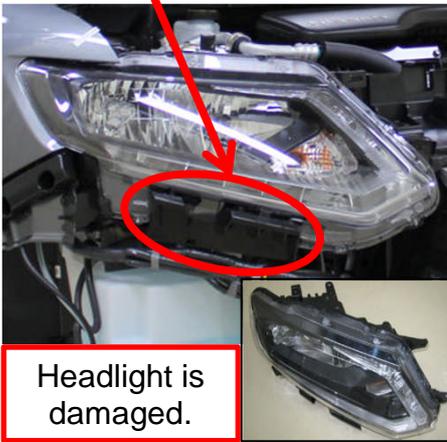
After Test

## Poor Example

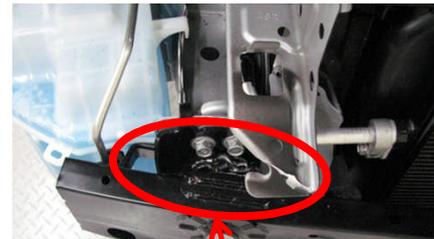
Crush stroke is too short for the crush box to absorb all of the crash energy.

When the crush stroke of the front crush box is 160 mm or more and energy absorption capability is ensured, damage is less likely to spread to the side member. Also, when bolts are used to facilitate removal and installation, man-hours for replacement work performed after the shock is absorbed can be reduced.

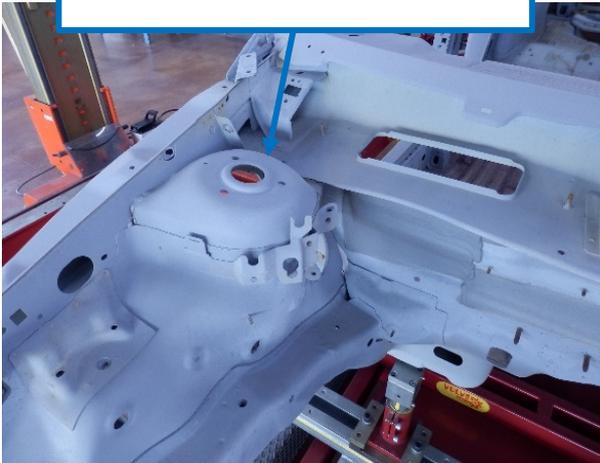
Strut tower has been designed as a separate part to easy its removal.

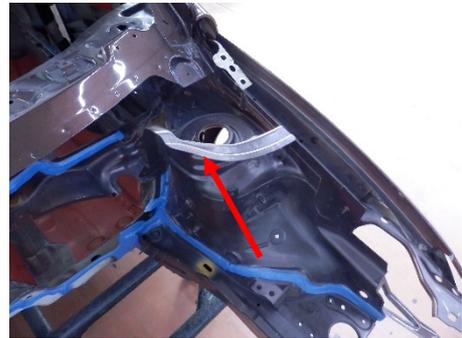
Disassembly of strut tower could be difficult due to the accessibility

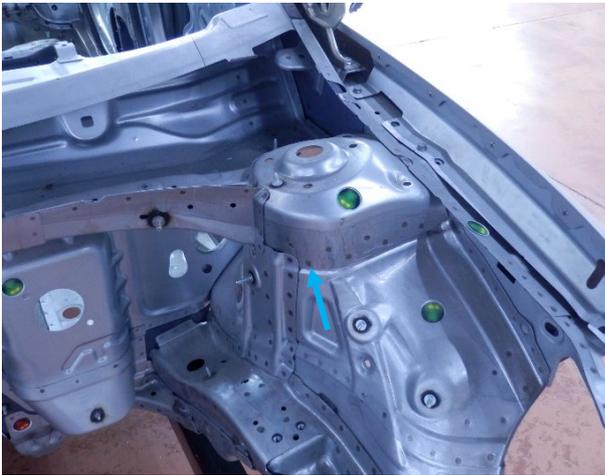
Strut tower has been fitted to the body using spot weld. Any evidence of repair could be removed.

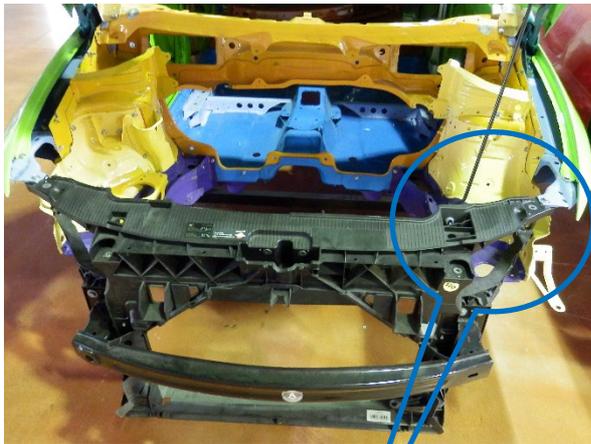
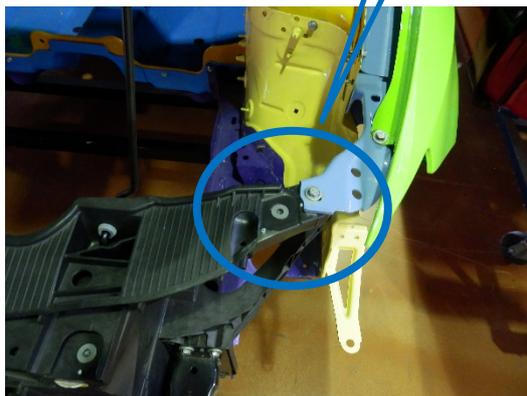
Front panel is a bolt-on part. Its disassembly is easier.

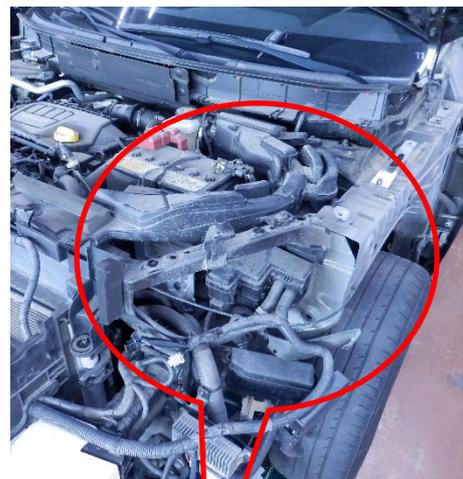
Front panel welded to side member. Its disassembly could be more difficult.

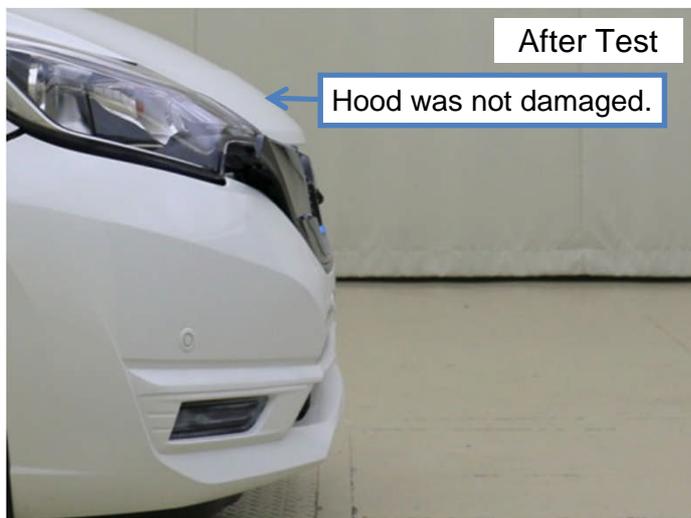
The hood was not damaged because the distance from the front end of the bumper to the front end of the hood was longer than the maximum collision penetration depth.

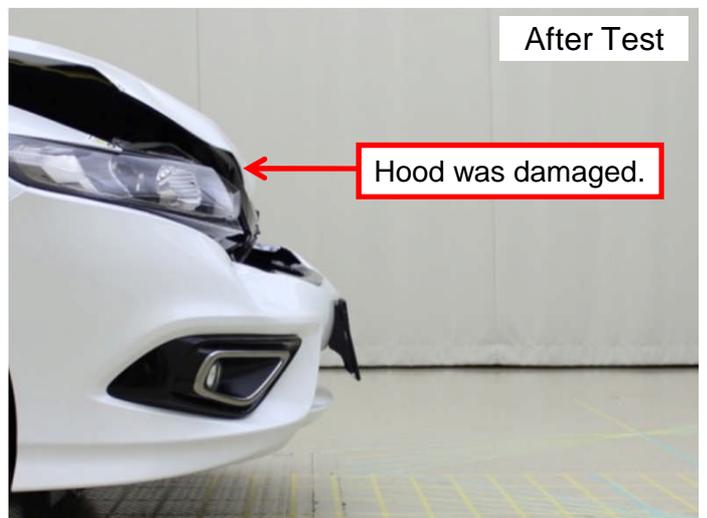
The hood was damaged because the distance from the front end of the bumper to the front end of the hood was shorter than the maximum collision penetration depth.

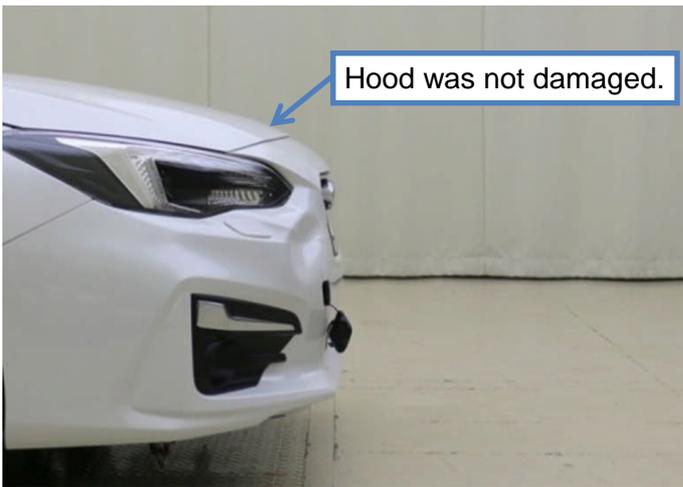
The hood was not damaged because the front end of the hood was higher than the barrier back stop.

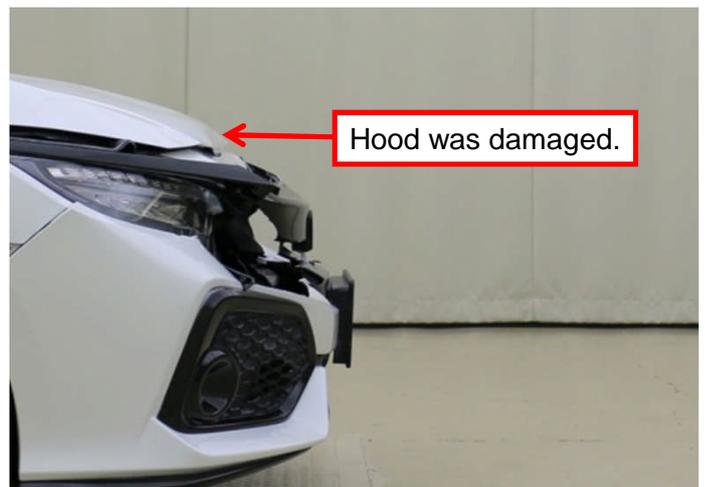
The hood was damaged because the front end of the bumper was lower than the barrier back stop.

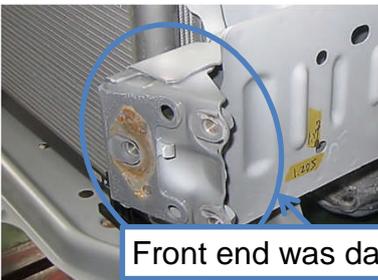
Front end was damaged.

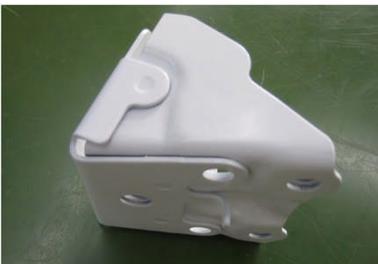
The front end part is supplied individually.

The part at the front end of the front side member, where the bumper reinforcement or crush box is installed, should be easily replaced and supplied individually.

When the part at the front end of the front side member, where the bumper reinforcement or crush box is installed, is easily replaced and supplied individually, if the front end of the side member is damaged, it is not necessary to take the front end part from the side member assembly and install it to the front side member, which reduces the repair cost.

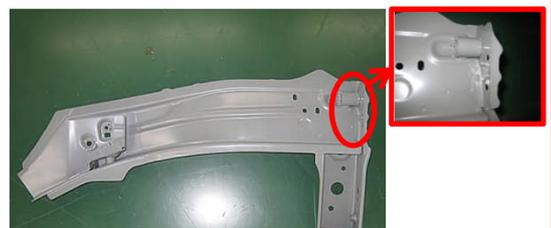
Front end was damaged.

The front end part is supplied with side member as an assembly, so it had to be removed from the assembly.

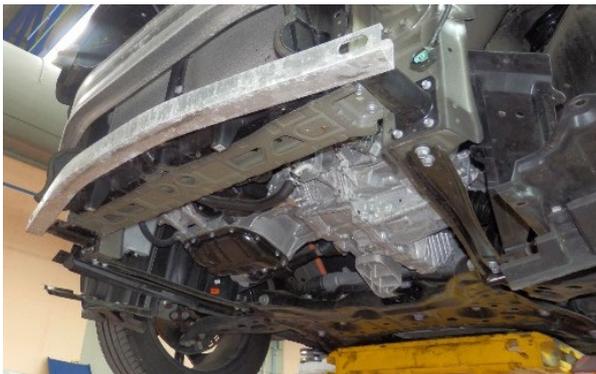
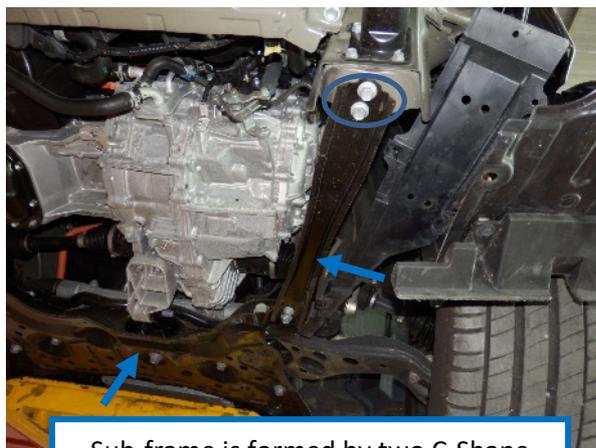
Sub-frame is formed by two C-Shape single parts, fitted via bolts.  
Disassembly requires less time.

If sub-frames are conformed by two or more simple pieces, the repair operation is easier. In that case it should be removed only the area affected (not the whole part).

If the sub-frame is fitted as far back as possible and it also could contain crush cans to absorb energy, subframe damage would be reduced in case of accident.

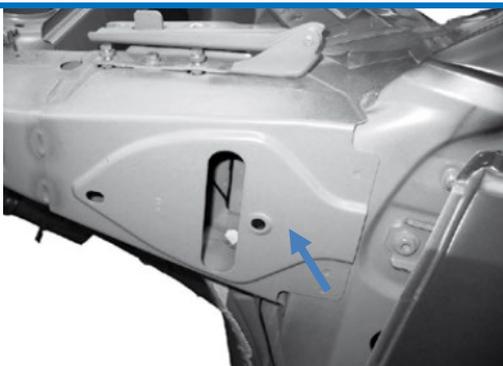
Bridging plate has been disassembled

Bridging plate creates a joint between 'A' Post and side panel reinforcement, easing removal of both panels.

Avoid the overlap of "A" post under the side panel reinforcement and roof reinforcement to make easier the replacement and reduce the repair times.

In case of roof reinforcement would be fitted on the 'A' post (and not under the 'A' post), it is recommended to be conformed by several parts.

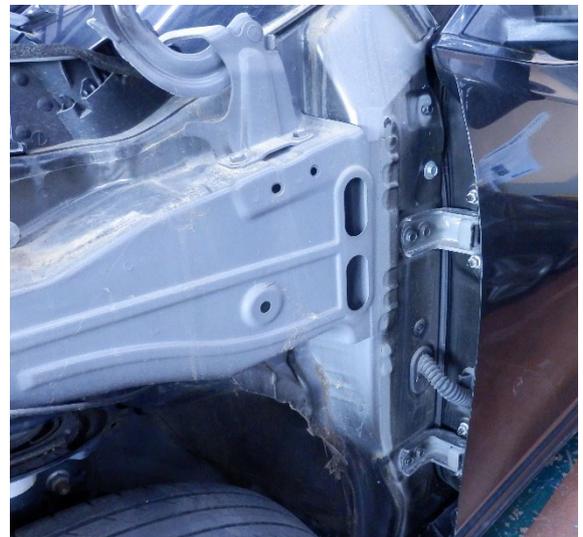
'A' Post reinforcement is a unique part. Its removal required its complete disassembly.

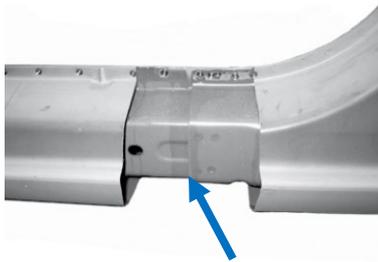
'A' Post cover and reinforcement where it joins the sill which are sectionable, making removal of the 'A' Post reinforcement easier and allowing for sectioning of the sill.

The possibility of removing sill reinforcements without extensive removal of other parts is recommended. This can be achieved by having reinforcements made of sections, allowing partial removal and reducing labour times and parts

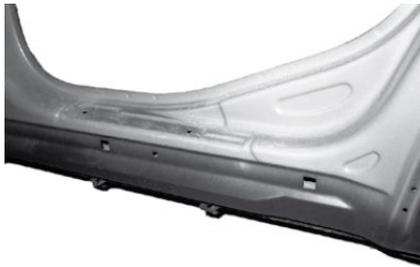
Sill cover panel runs from edge to edge over the reinforcement around the 'B' Post and rear reinforcement.

When sill panels are joined to the chassis or the floor, a single joint is preferred over a bridging panel joining the sill panel and floor, as this reduces accessibility. It makes repairs awkward when both panels are damaged and increase the repairs times.

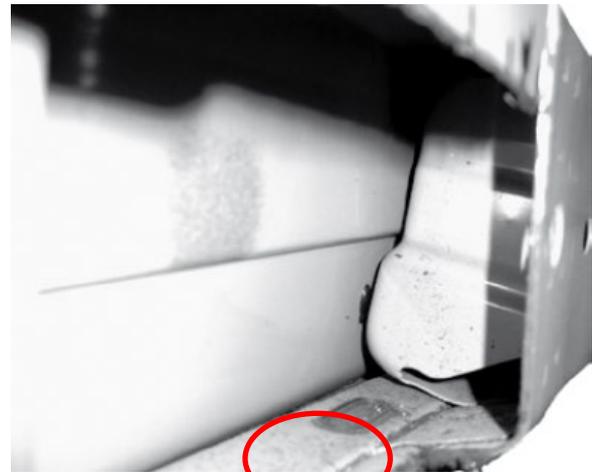
The sill cover panel runs to a bridging panel, not to the inner edge of the chassis/floor.

Reparability could be difficult due to the accessibility

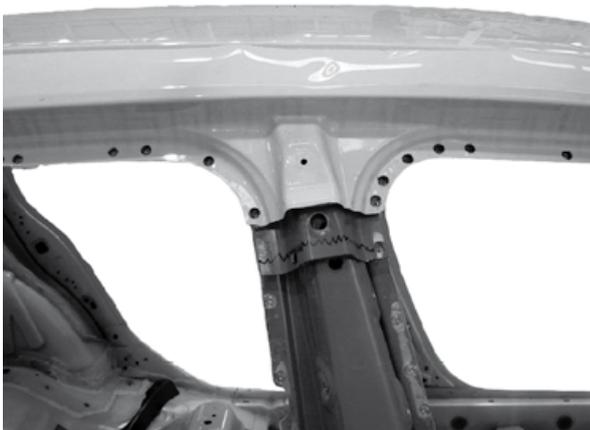
'B' Post can be sectioned though reinforcements and both outer and closing panel without having to cut into upper roof rail. Most reinforcements made from UHSS cannot be sectioned.

Allow enough space for tooling, as specified in existing repair manuals, between the panels for sectioning in likely areas of repair.

The areas where several panels of different materials are used proximity create body side assemblies do not allow safe sectioning in repair. Due to the order of panel removal and stepping the joints, damage to subsequent panels can occur. This damage must be avoided, as it will reduce the strength.

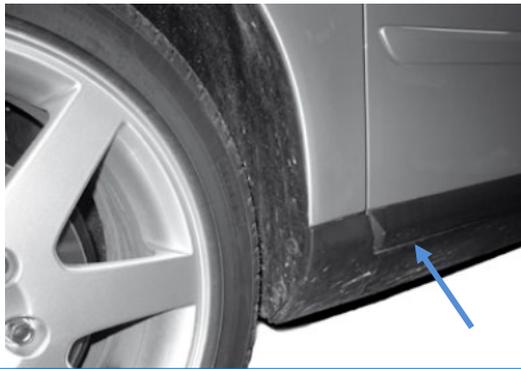
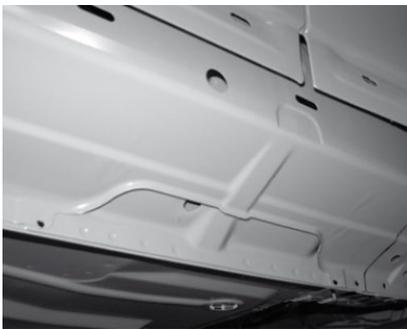
Sill cover panel runs from front edge to rear edge, over the reinforcement and around the 'B' Post and rear reinforcement. Sill shape is given by fitting a plastic cover.

Design sill covers as cosmetic panels only which can then be removed easily. Reinforcement should be made of separate parts to limit the requirements for removal. This will reduce times and make the repair easier.

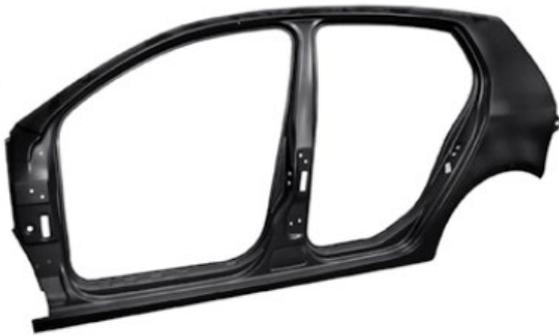
Service parts supplied as a whole that can be cut where required to suit the damage to the vehicle. This avoids any mismatching joints.

The servicing of a good priced whole-body side panel avoids discrepancies on joints and also allows the repairer to cut the best section for each repair. Parts of panels can be separated out of the whole-body side and accurately positioned according to the damage on a vehicle.

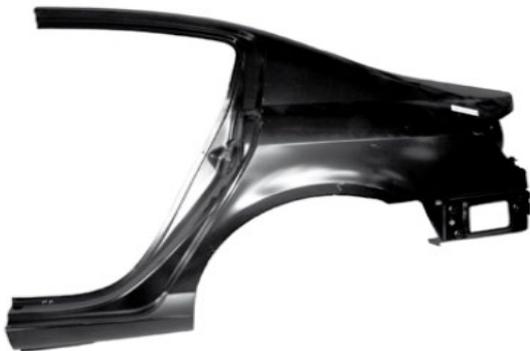
Service parts supplied as a whole rear segment to cover the most vulnerable parts like the dogleg.
