# NEW DESIGN GUIDE

2020

This New Design Guide is a complete updating of the previous one. The REPAIRABILITY Working Group has removed the obsolete points and added new ones so that the new content is in line with the latest technologies.

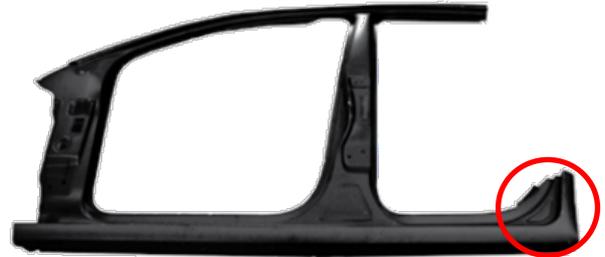
Service parts supplied as a side panel segment but having a joint at one of the most vulnerable and most frequently damaged parts like the dogleg.

Service parts are normally available as separate panels. Although this is in principle a good solution, the reality is that outer panels are cut from whole body sides and the location of the cuts varies, resulting in service panels not joining accurately. Also damage to the vehicle may occur between areas covered by two service panels

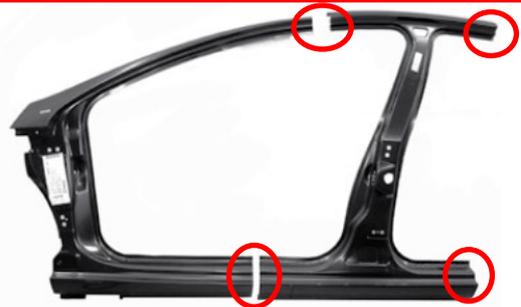
Service parts supplied in separate units need joining up when fitting, unless the part covers the damage area.

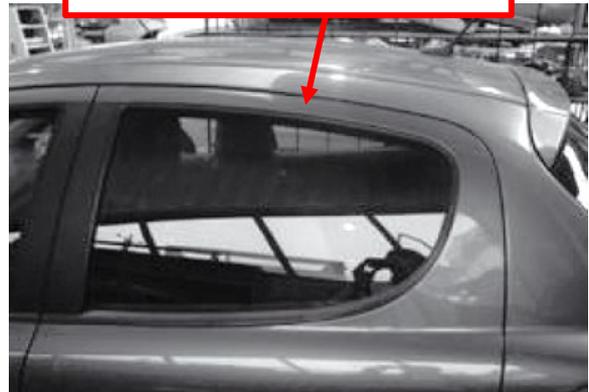
With upper window frame

The door-skin with upper window frame will be difficult to replace

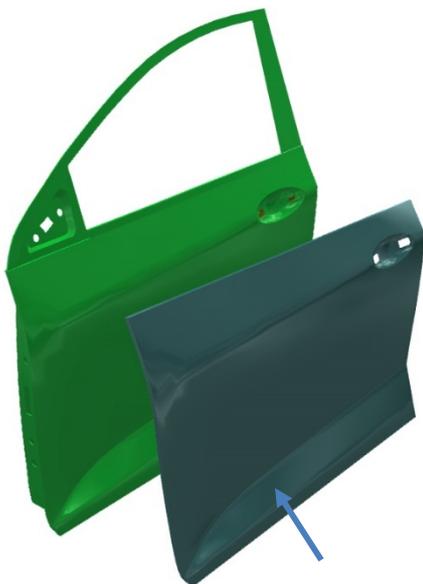
The door-skin is supplied as a separate part. In case of damage, only door-skin is removed

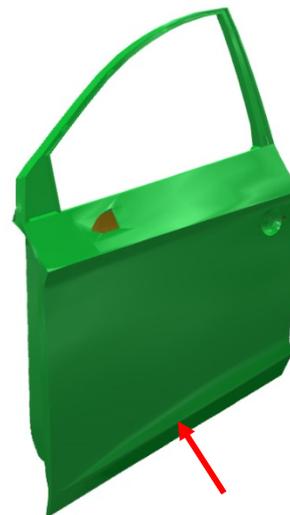
Door is supplied as complete part. There is no possibility of partial replacement.

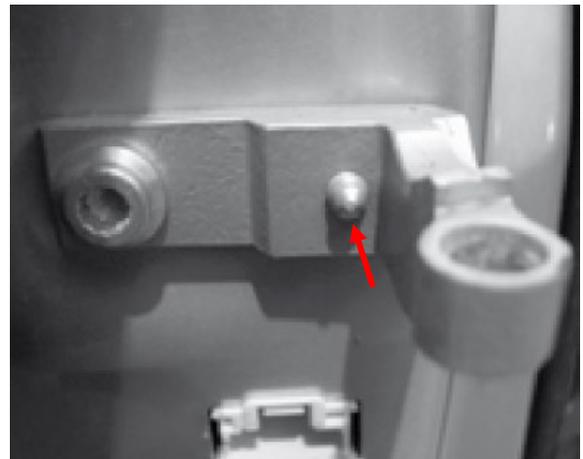
The access to the bolt causes problems in the repair. It is necessary to access from inside bodyshell, increasing the labour time.

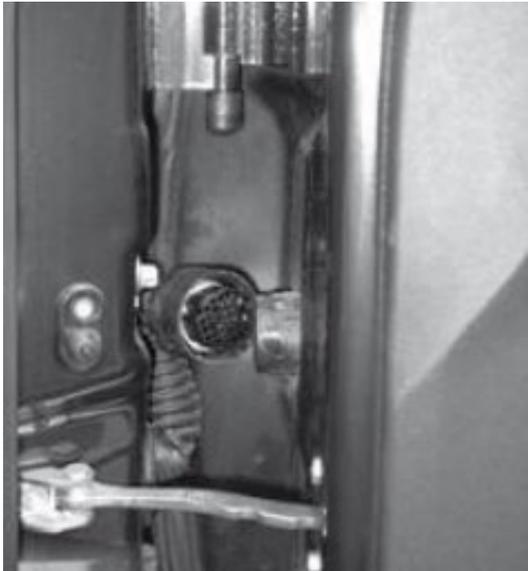
A central electrical multi-connector will make it easier to remove the door.

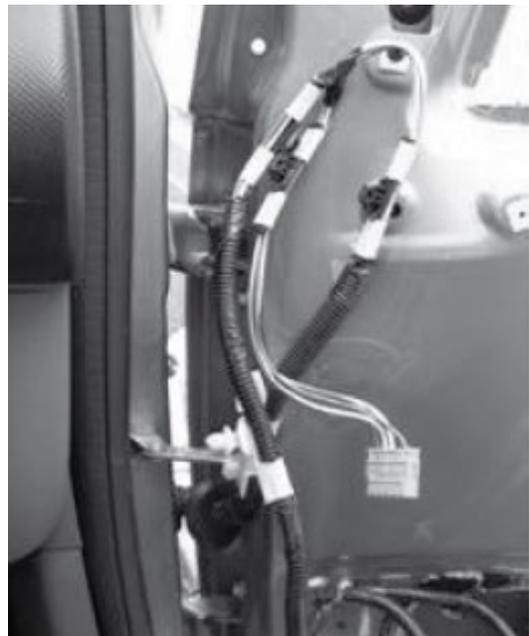
The door does not have a central electrical multi-connector, so it is necessary to remove the door trim and to disconnect the different electrical devices.

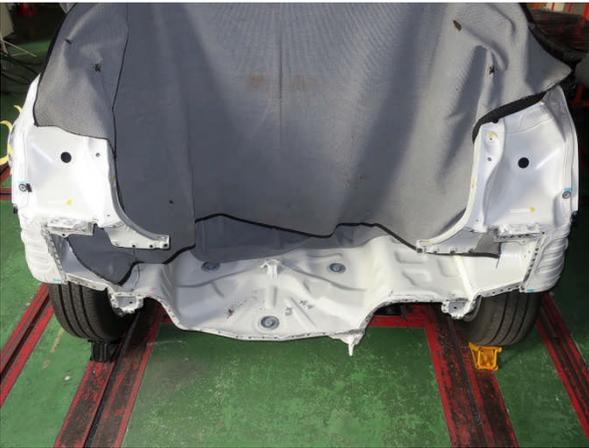
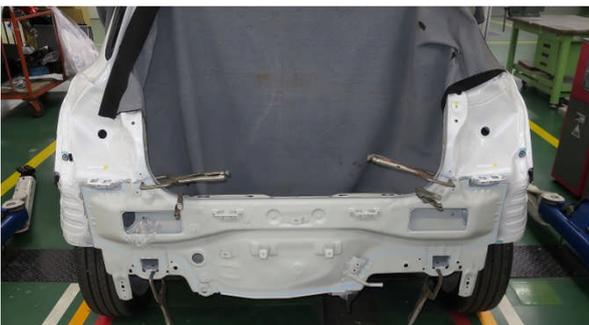
The adjacent panels did not have to be removed to replace the rear panel because the rear panel was installed in the outermost position.

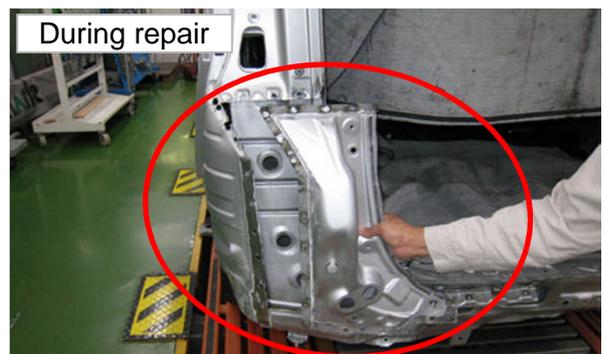
The adjacent panels had to be removed because the rear panel was installed in the inner position.

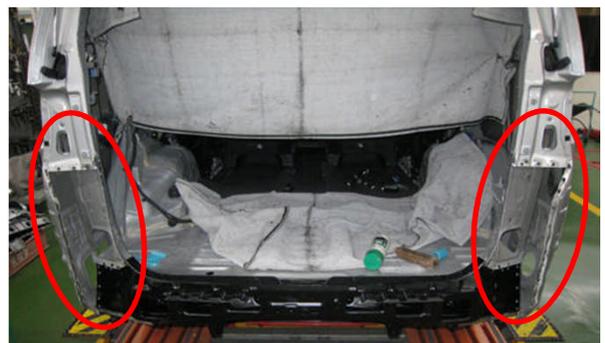
The left and right adjacent panels were removed so that the rear panel could be replaced.

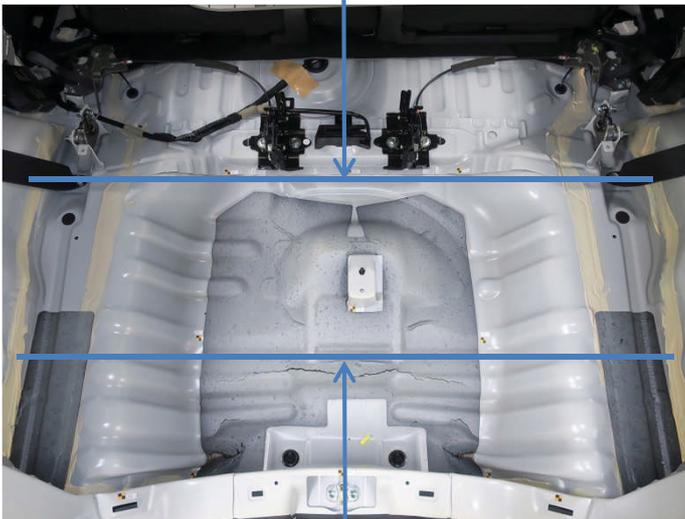
Sectioning position for when the damaged area is large.

Sectioning position for when the damaged area is small.

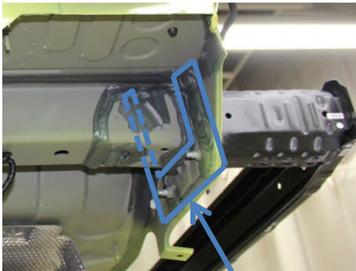
Before Test

Rear end of the side member has rigid reinforcement.

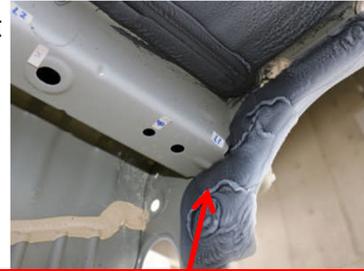
Before Test

Rear end of the side member does not have reinforcement and is weak.

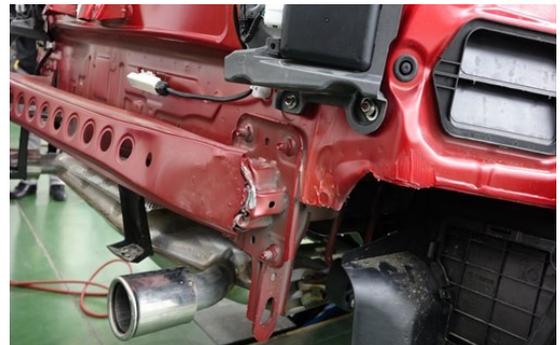
<b>Element</b>	Rear bumper reinforcement with rear crush cans.
<b>Material</b>	Metallic
<b>Results</b>	Good results
<b>Structural Damages</b>	There aren't damages on the rear body panel
<b>Damageability</b>	A good length of rear crush cans and clearance between bumper reinforcement and surrounding parts
<b>Repairability</b>	The barrier has bolts to easily replacement.

Deformation in bumper reinforcement

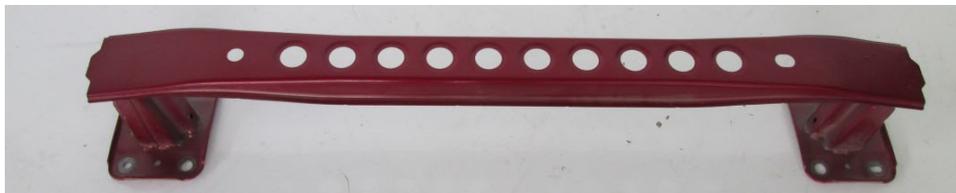
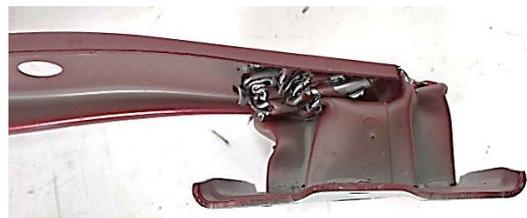
Deformation in rear crush cans

**Note:** The design and the material of the bumper reinforcement produces a good deformation that absorbs the energy of the crash.

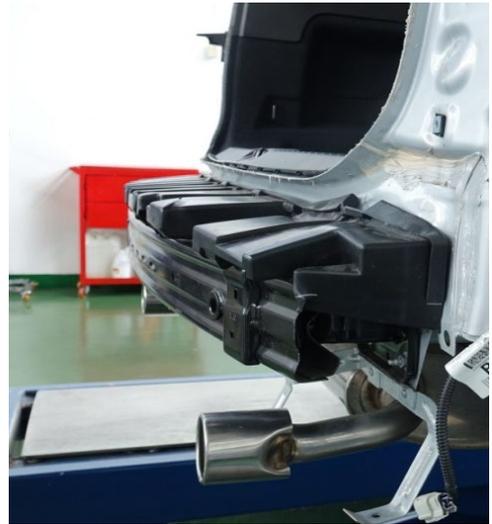
Element	Rear bumper reinforcement with rear crush cans, and plastic elements
Material	Metallic and plastic
Results	Good results
Structural Damages	There aren't damages on the rear body panel
Damageability	A good length of the rear crush cans and clearance between bumper and surrounding parts
Repairability	The barrier has bolts to easily replacement

Deformation in bumper reinforcement

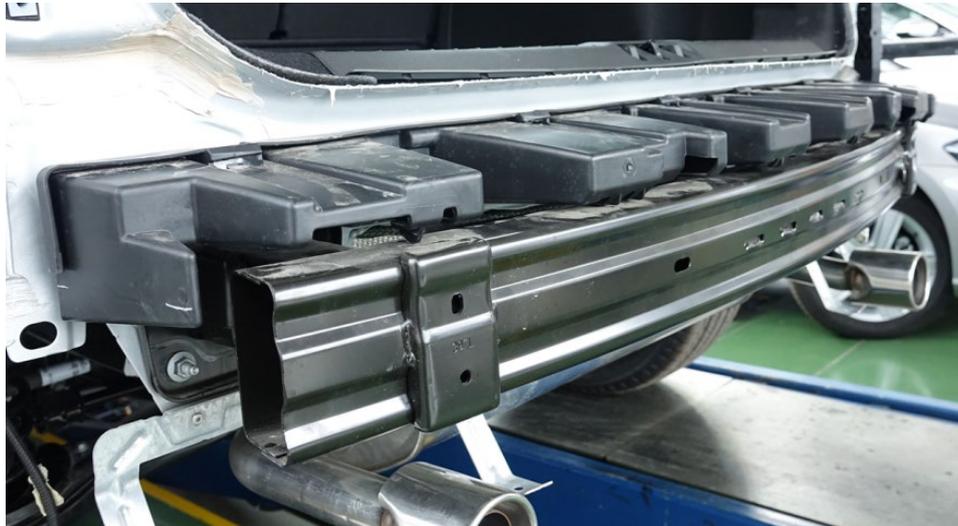
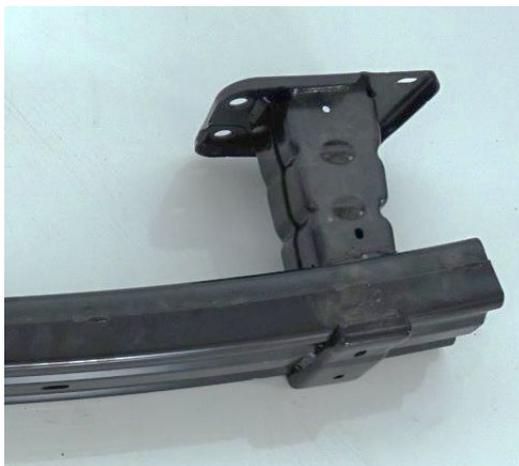
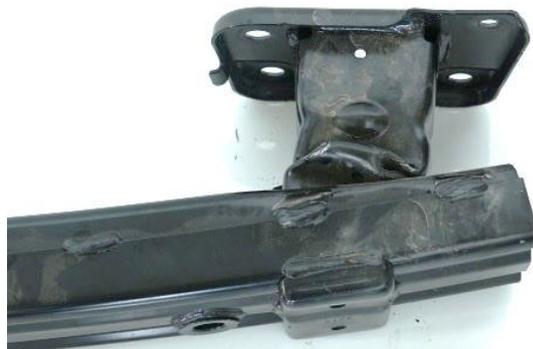
Deformation in rear crush cans

**Note:** The design and the material of the bumper reinforcement produces a good deformation that absorbs the energy of the crash.

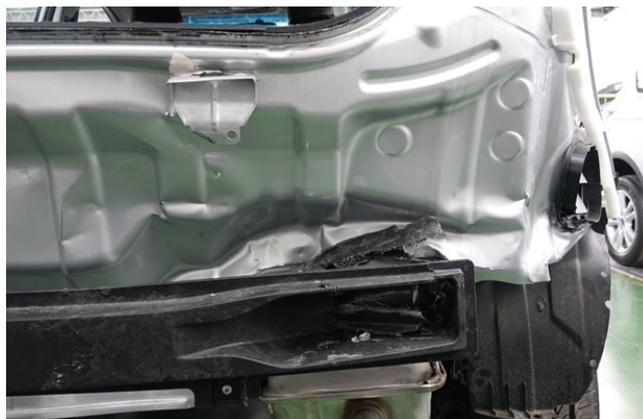
Element	Rear bumper reinforcement with rear crash cans.
Material	Reinforcement has compound by plastic and fiber material
Results	Poor results
Structural Damages	Severe damages on rear panel, rear chassis leg side left and boot floor
Damageability	The reinforcement was broke up
Repairability	The reinforcement has bolts to easily replacement

Damages on the body structure

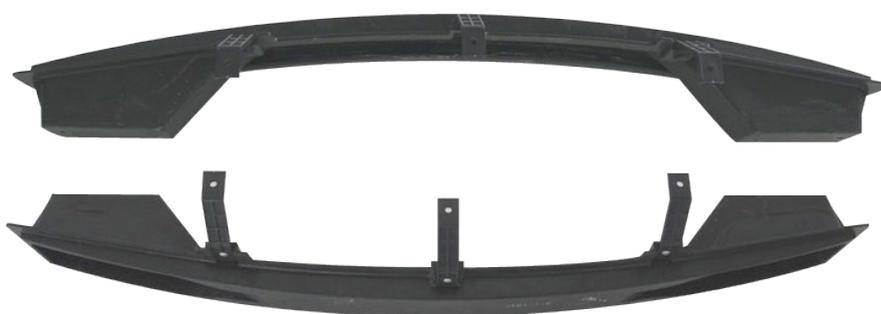
Rear bumper reinforcement

The bumper reinforcement was broken

**Note:** The reinforcement was broken, therefore the element do not deform and the energy of the crash is transmitted to the body structure.

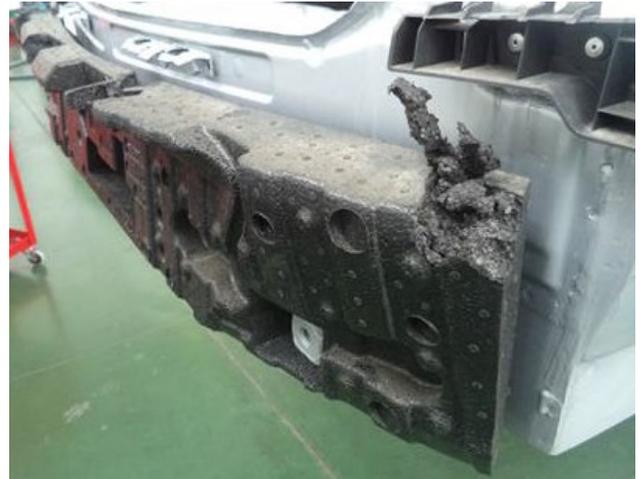
Damages on the rear panel

Element	Only polystyrene without reinforcement
Material	Polystyrene
Results	Poor results
Structural Damages	Several damages on rear body panel, rear chassis leg, side left and boot floor, these parts were replaced. The rear panel was repaired.
Damageability	N/A
Repairability	The polystyrene is mounted on the rear panel.

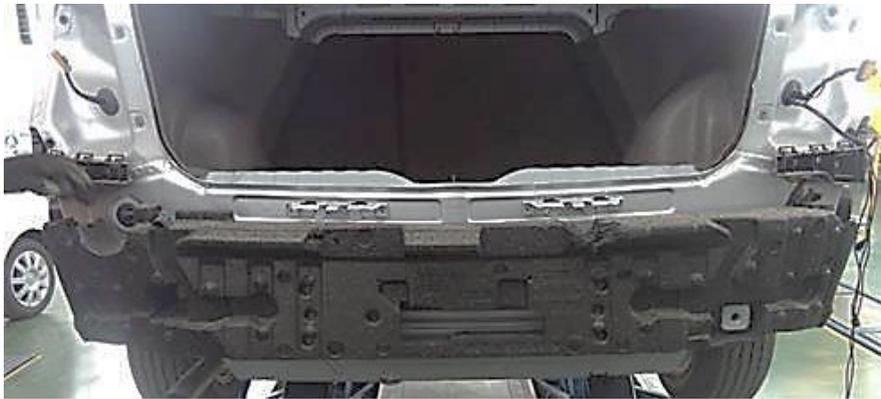
Only polystyrene mounted on the rear panel

**Note:** The vehicle only have polystyrene on the rear panel. Therefore, the protection to the rear body panel and the structure of the car is very poor.

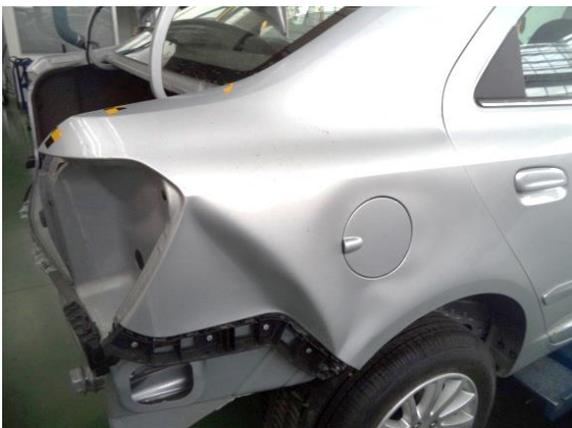
Repair side panel

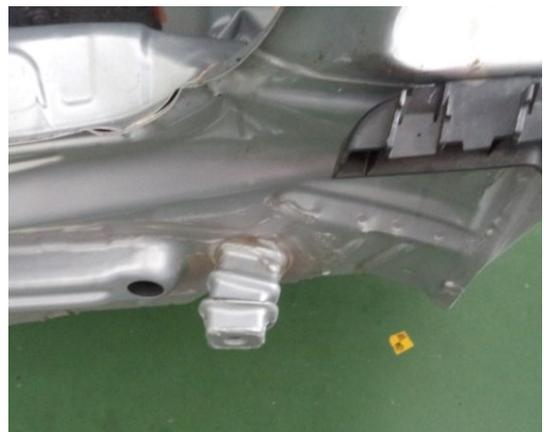
Replace rear panel

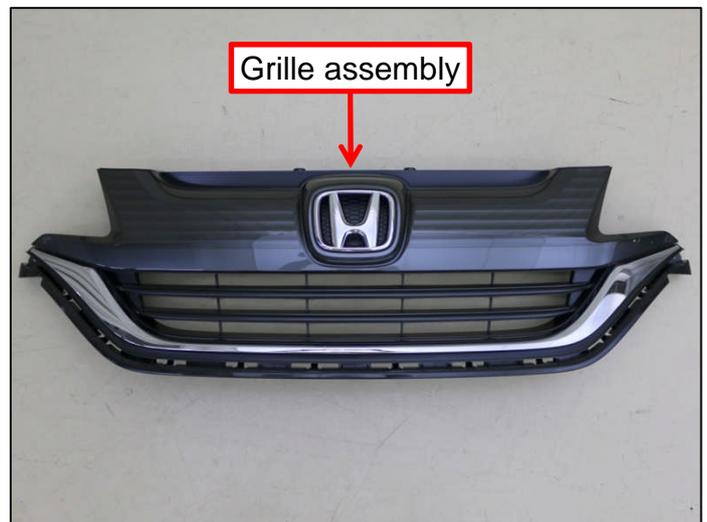
The grille base and molding are not supplied individually.

When the radiator grille consists of a molding and radiator grille base and the molding and grille base are supplied individually, if either part is damaged, only the damaged part needs to be replaced, which reduces the repair cost.

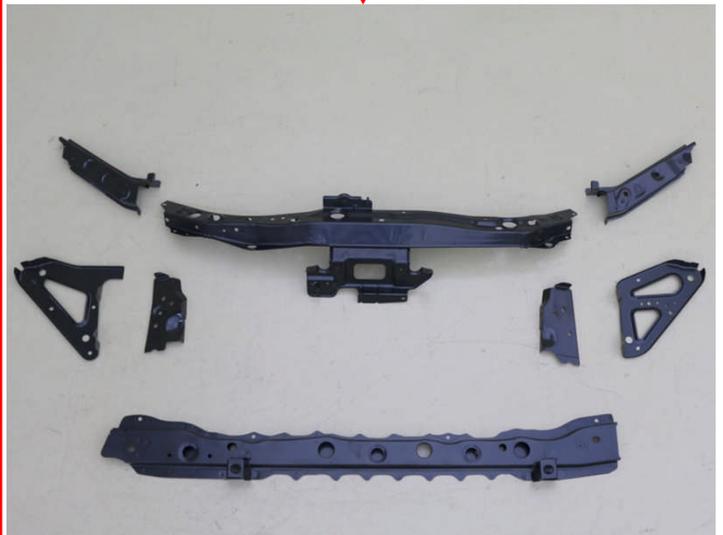
• Not supplied as an assembly.

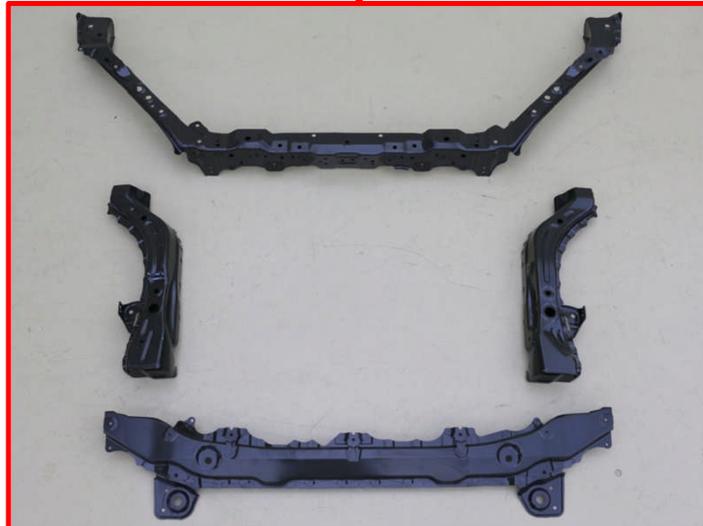
The upper, lower, and sides of the radiator core support are welded.

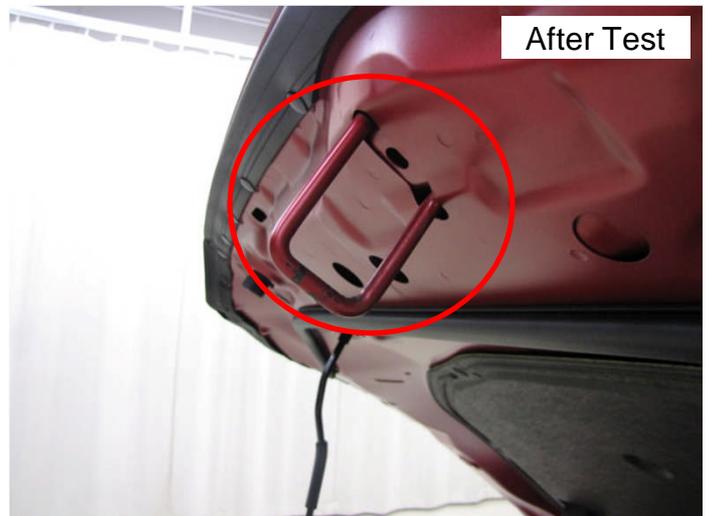
Hood was damaged via the hood lock.

Hood striker is located on the front portion of the hood and the front to rear length of the striker is shorter than the distance the hood lock slides

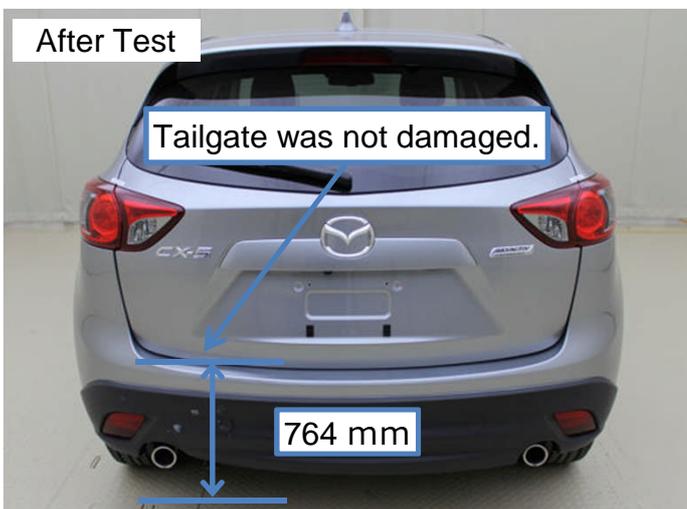
1.4.21

# TAILGATE/TRUNK

When the bottom end of the tailgate (or trunk) is higher than 705 mm, damage to the tailgate (trunk) is less likely to occur.

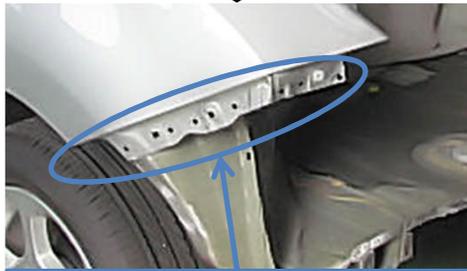
The lower section of the rear quarter panel is separated from the upper section.

The lower section of the rear quarter panel was removed.

When the rear quarter panel is divided into upper and lower sections or the lower section can be cut off to be replaced, if the lower section is damaged, the rear quarter panel assembly need not to be replaced, which reduces the repair cost.

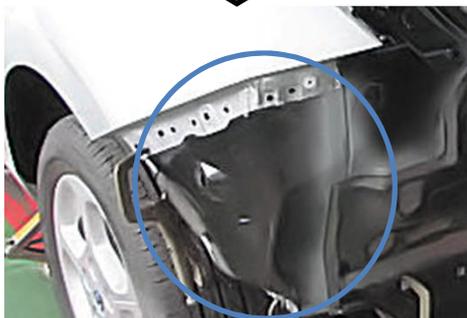
Only the lower section of the rear quarter panel was replaced.

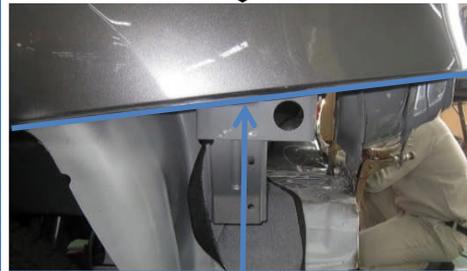
The lower section of the rear quarter panel can be cut off to be replaced (sectioning).

The lower section of the rear quarter panel was cut off.

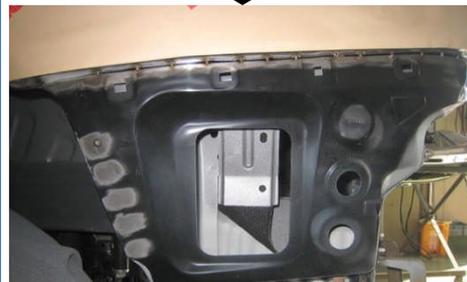
Only the lower section of the rear quarter panel was cut off and replaced (sectioning).

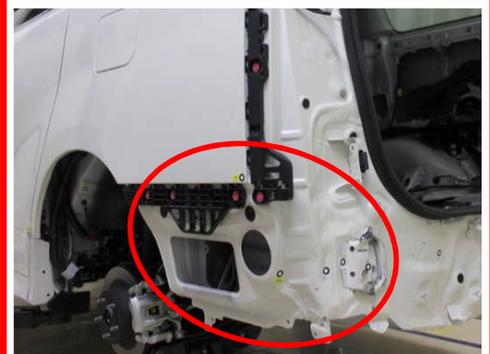
The lower section of the rear quarter panel cannot be cut off to be replaced (sectioning).

Although only the lower section of the rear quarter panel was damaged, the rear quarter panel assembly had to be replaced as sectioning was not an option.

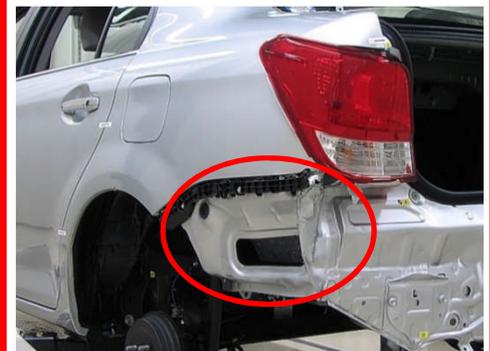
Although only the lower section of the rear quarter panel was damaged, the rear quarter panel assembly had to be replaced as sectioning was not an option.

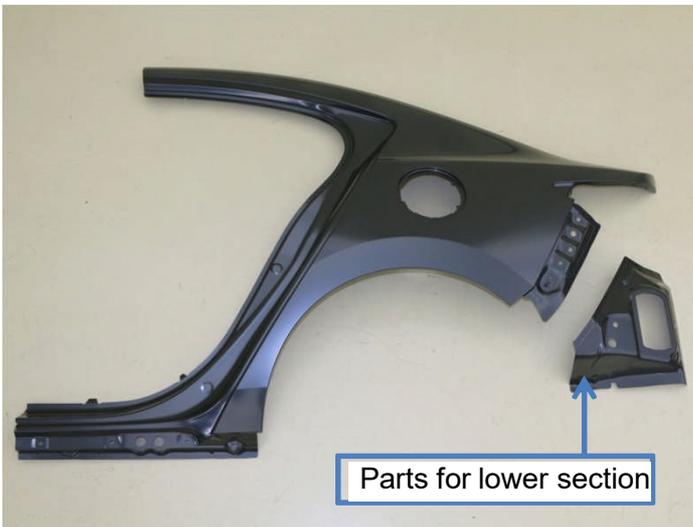
The lower section of the rear quarter panel is supplied individually.

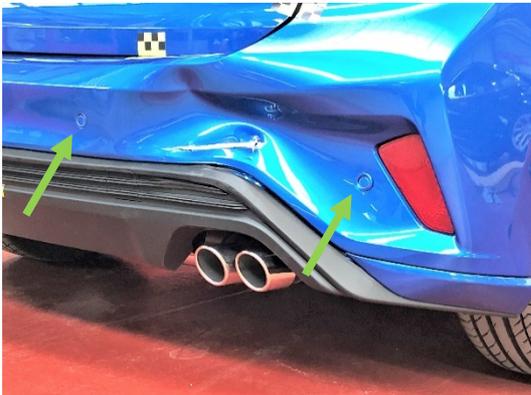
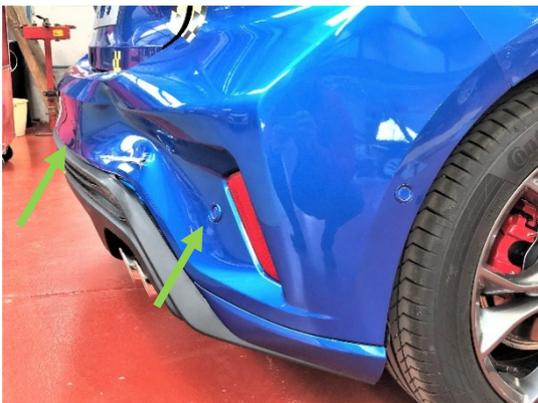
Parking sensors installed in parts independent of the bumper and in a rearmost position than outer surface of the bumper. That increases the difficulty of being damaged in impacts of the bumper.

After test

The parking sensors should be mounted on moldings and removable grilles independent from the bumpers, and should be placed in a rearmost position than the outside of the vehicle to minimize possible damage due to a direct hit on them.

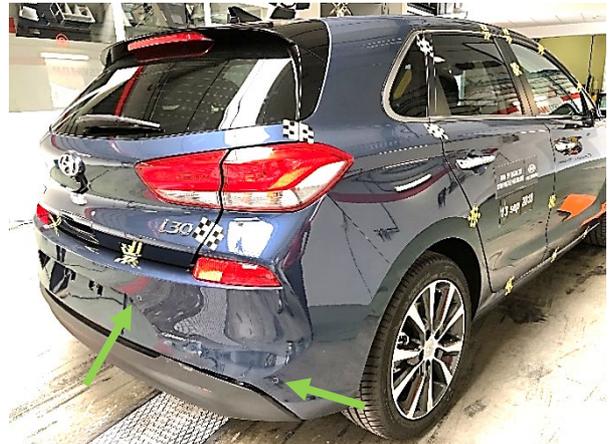
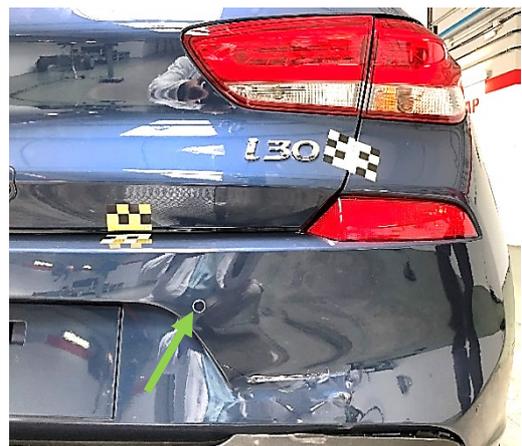
Parking sensors installed on the surface of the rear bumper and in an area very exposed to direct impacts.

After test

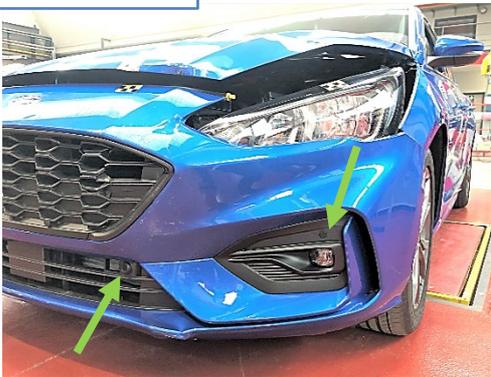
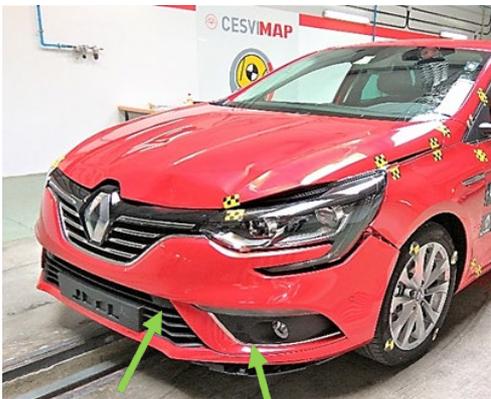
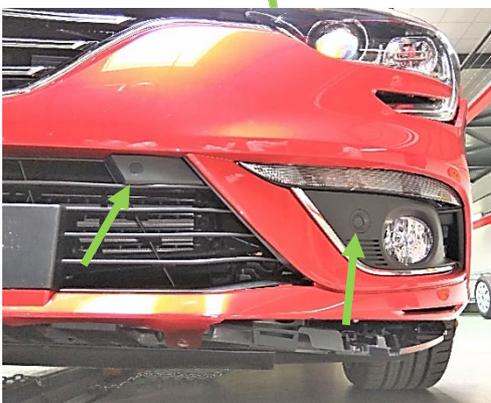
**FRONT BUMPER****Good example**

Parking sensors installed on supports independent from the bumper and in a rearmost position from the outer surface of the bumper will have no damage in impacts on these areas.

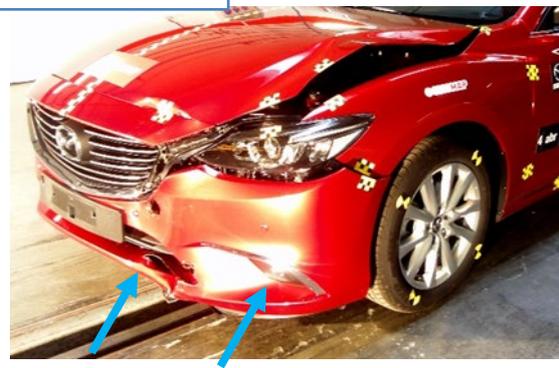
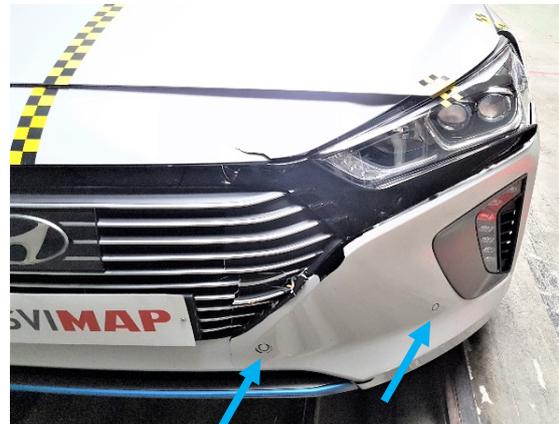
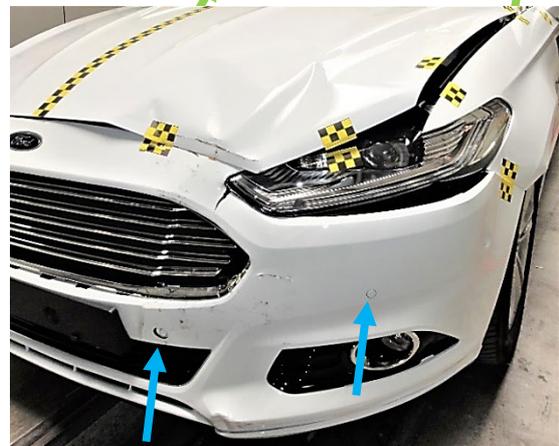
Parking sensors installed on the surface of the bumper are highly exposed to be damaged in impacts to the bumper.

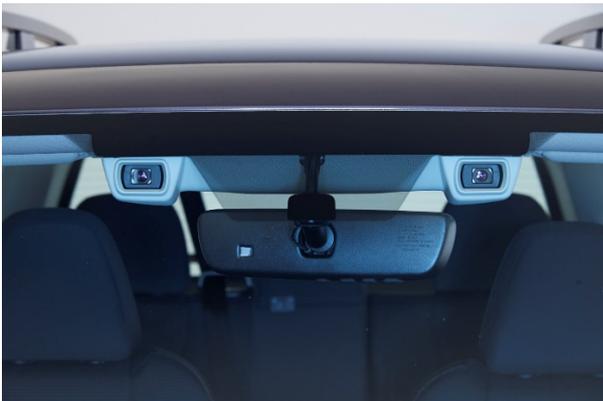
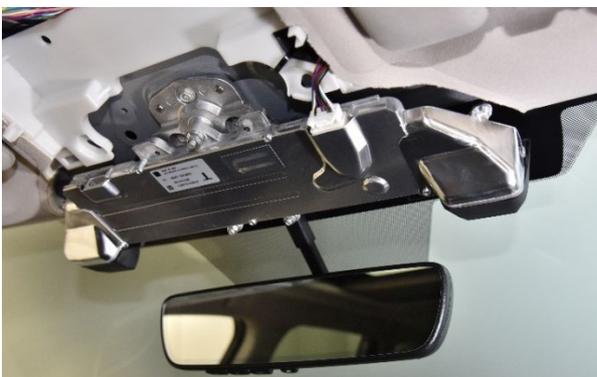
### FRONT VIEW CAMERA

Good example

To avoid potential ADAS system issues, the front view camera should be mounted in such a way that its removal and installation is not required when performing a windshield replacement. Additionally, post windshield installation calibrations, if needed, should be minimum.

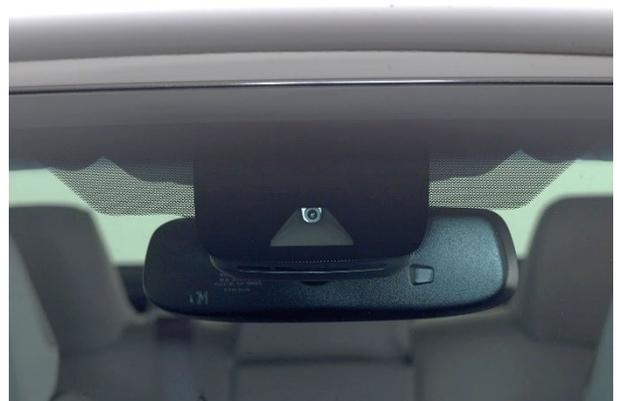
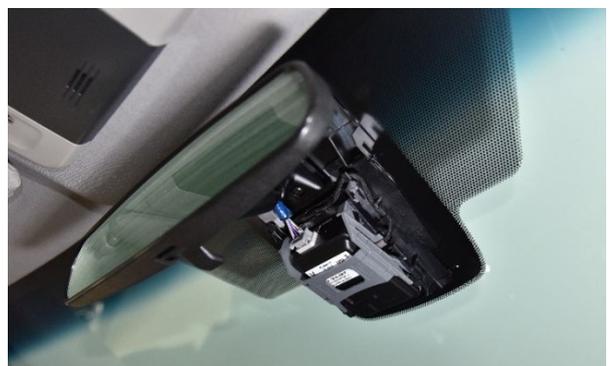
Poor Example

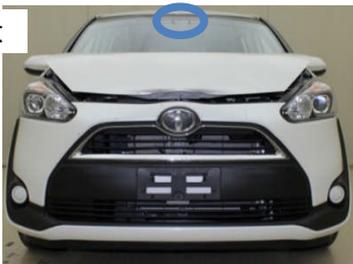
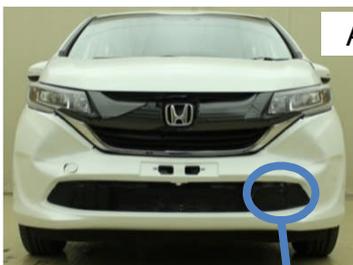
Installed on the windshield where damage to the radar sensor is less likely to occur. (Example where LIDAR is installed)

Example where damage to the radar sensor did not occur during the D&R test at Jiken center.

The radar sensor is expensive. When it is installed on the inside of the windshield or other location that is not on the front portion of the vehicle, damage is less likely to occur.

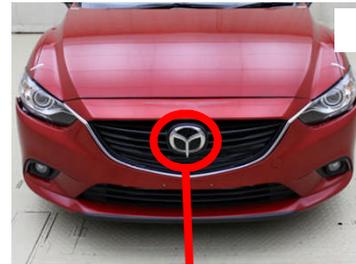
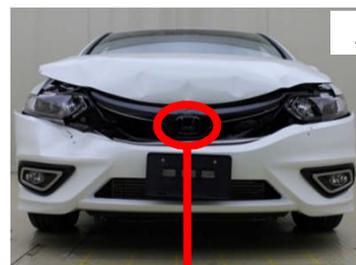
Installed on the back side of the bumper cover. Damage to the radar sensor occurs when pressed.

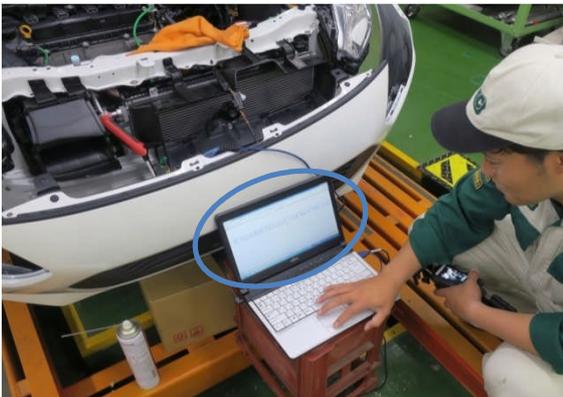
Whether or not the millimeter-wave radar is radiating correctly can be checked with the oscilloscope function of a PC with a diagnostic device installed.

When the inspection procedure for the radar sensor function is provided in the repair manual, it helps determine whether the sensor is usable or not when the sensor does not have any sign of external damage. This prevents unnecessary repairs, reducing the repair cost.

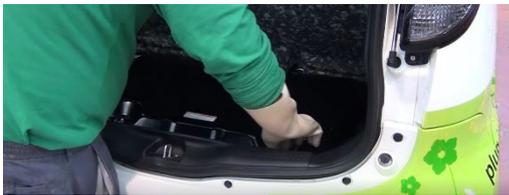
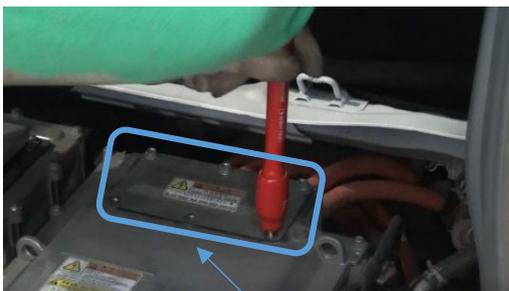
It is possible to verify quickly if the vehicle is in electric safe mode due to the check box

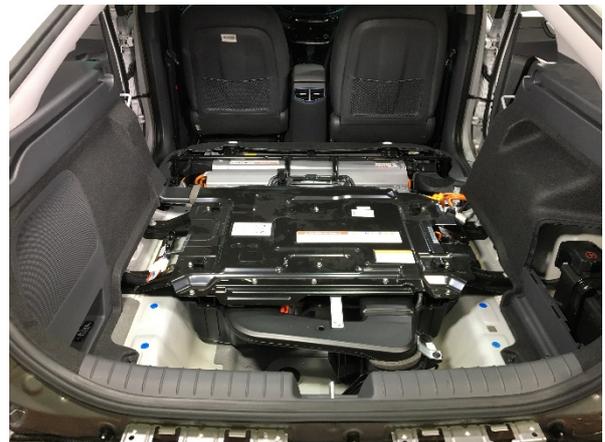
NO Check box

There is no check box, so the operator need more time to verify, at various specific points of the electric system, if the vehicle is in electric safe mode.

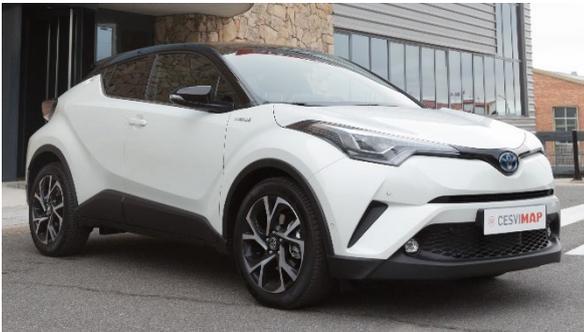
The high voltage cut off plug is locate in the lateral of the right rear seat

EASY AND DIRECT ACCESS

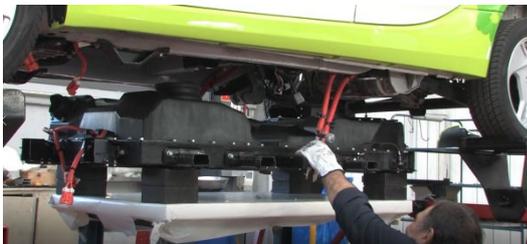
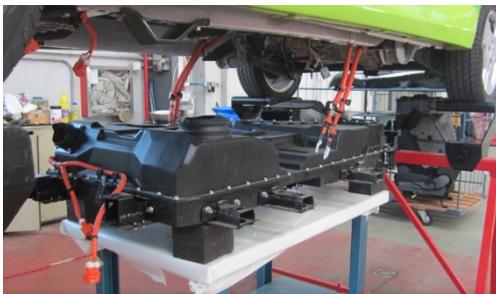
Well protect battery against collisions

If the battery is correctly secured and there is a safety distance between it and the other car elements, it is possible to prevent damage to the battery due to the displacement of these elements in collisions.

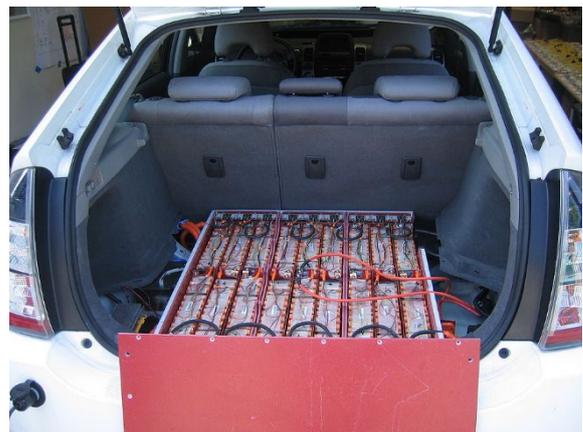
Poorly protected battery against collisions

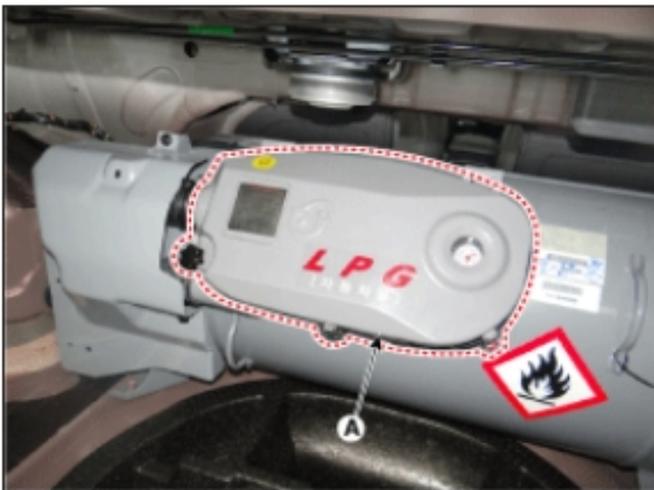
1. Open the trunk
2. Turn off the key and detach the minus terminal of battery
3. Open service cover (A)

When you repair gas supply system, you should remove the remain pressure.

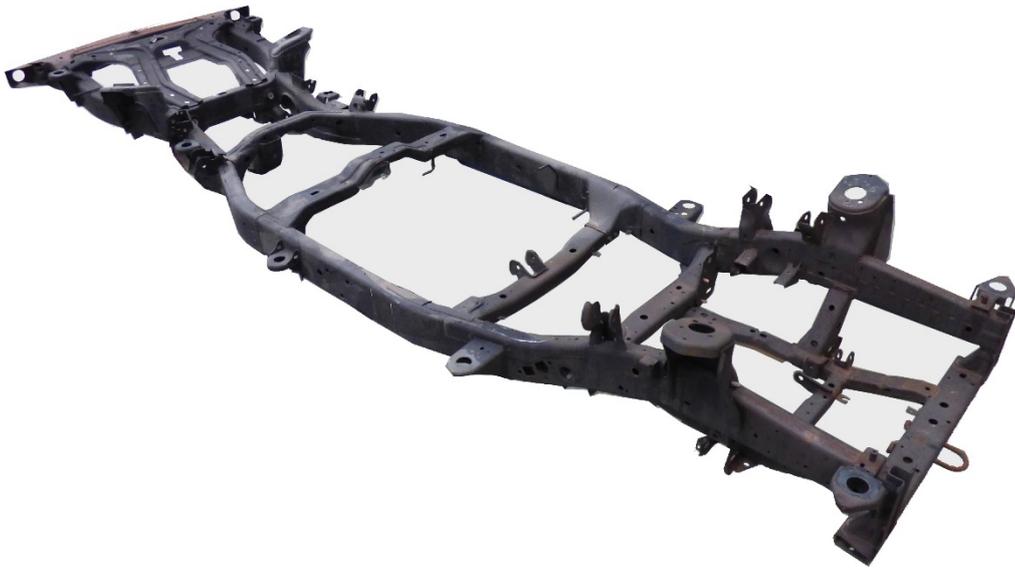
Manufacturers should give guidance on the use of welded tabs for minor frame deformation and cosmetic frame repairs (tabs are additional lugs welded onto the frame to create an additional pulling point, where standard points are not enough).

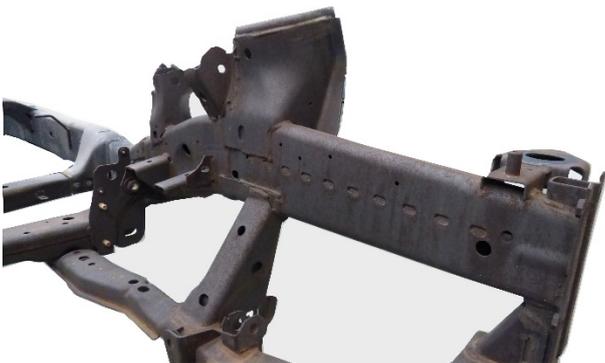
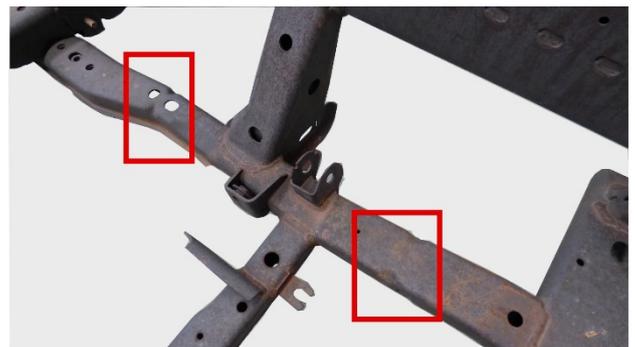
These fuse areas of the frame should be supplied as separate elements for easy replacement.

In low intensity crashes when the frame has these crush zones repairs are shorter in time and less expensive.
